# Morinville Heritage Survey

FINAL REPORT | May 2013

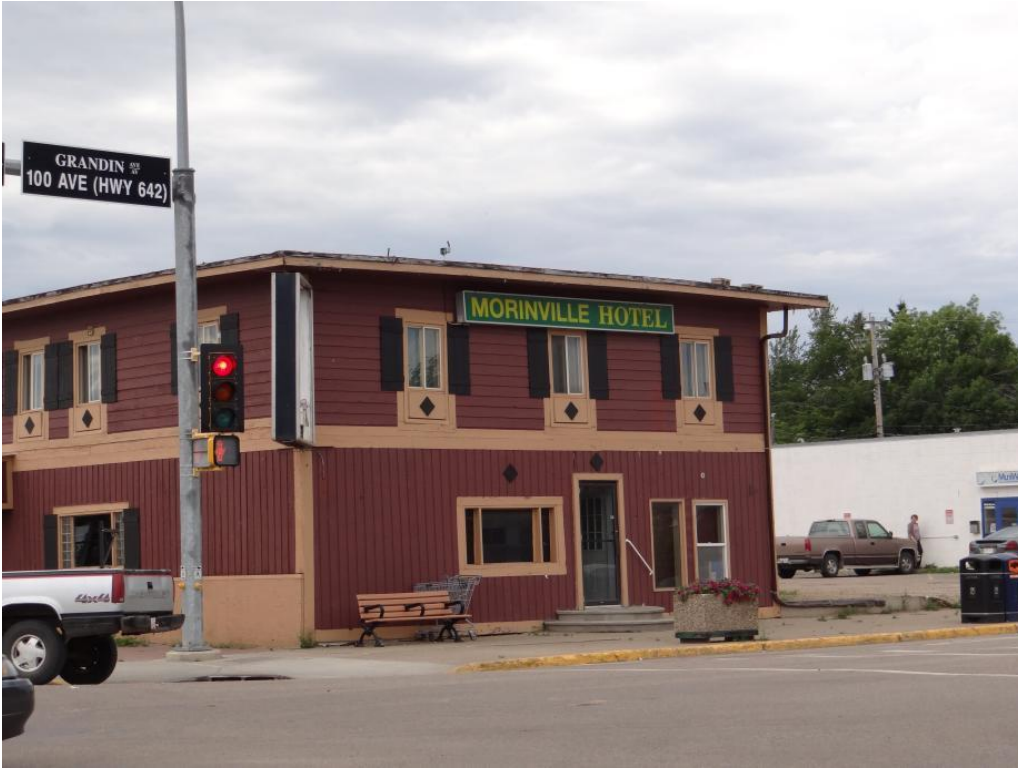
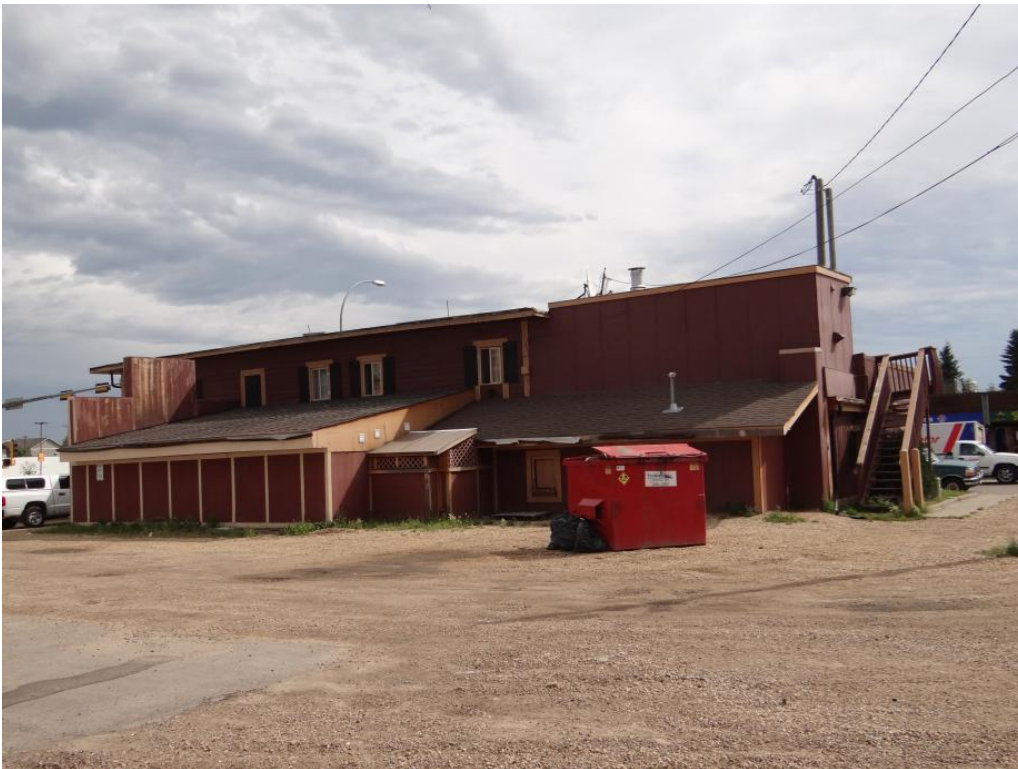
Architectural Style	N/A	Plan Shape	1202: Rectangular Long Façade
Storeys	1504: 2 (1701: no Basement)	Foundation	1807: Concrete
Superstructure	3011: Nailed Frame		
Superstructure Cover	2004: Wood (Vertical Wood) / 2010: Wood (Flush Board)		
Roof Structure	3219: Flat		
Roof Cover	3401: Unknown		
Massing	1101: Single Detached	Wings	1310: Rear and Right Side
Wall Design and Detail	3102: Plain Panel (Painted dominant earth tones, Decorated)		
Roof Detail	3503: Projecting Eaves		
Windows	4902: Flat (Plain Lintel/Sides, Decorated Slip Sill, Wood); 5610: Side Lights		
Main Entrance	6103: Off-Centre Façade		
Main Porch and Stairs	7102: Ground Floor, No Railing; 7208: Other (rounded); 7304: Open Porch (Wood/Metal)		
Exterior	The form, scale, and massing are a unique character for a commercial building, however the details are not original – the high hip roof, balcony, skirt roof and exterior finish were removed/altered and bear little resemblance to the original building.

Interior	The interior space is in need of maintenance and upkeep.		
Condition	Structure: Good. Upkeep: Fair.		
Alterations	Significant.

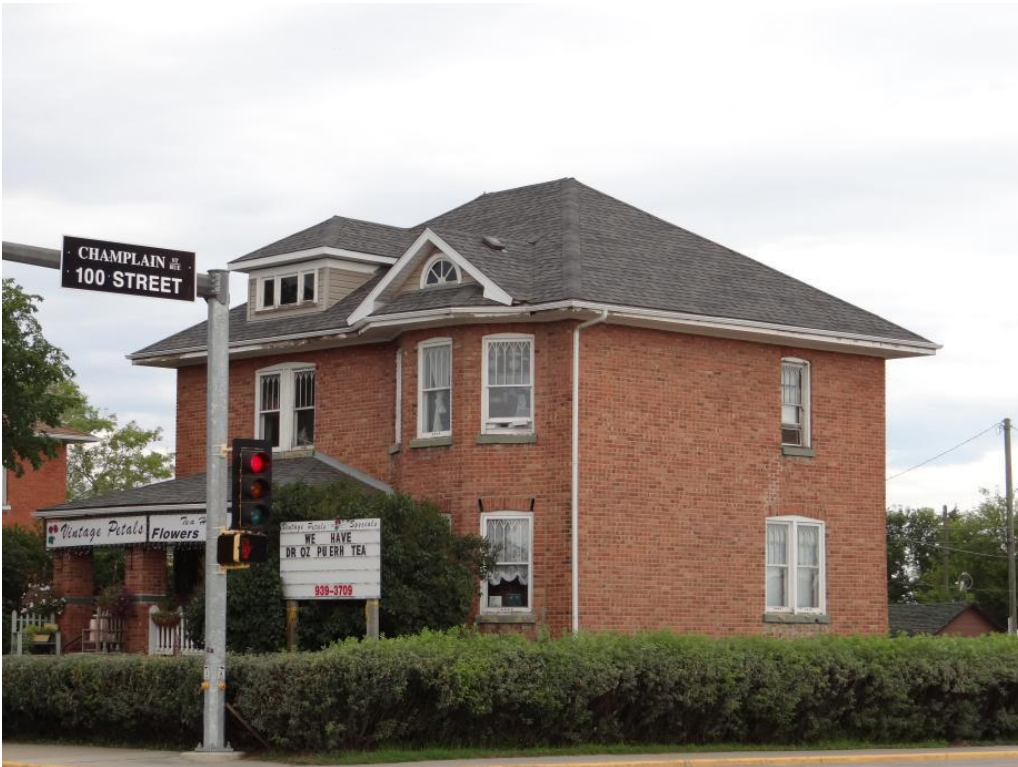
Filename DSC00861.jpg

Architectural Style	9031: Four-square	Plan Shape	1202: Rectangular Long Façade
Storeys	1504: 2 (1708: full-below Basement)	Foundation	1807: Concrete
Superstructure	3011: Nailed Frame		
Superstructure Cover	2303: Brick (Bond: Stretcher)		
Roof Structure	3208: Medium Hip		
Roof Cover	3405: Asphalt Shingle		
Massing	1101: Single Detached	Wings	N/A
Wall Design and Detail	N/A		
Roof Detail	3509: Moulded Soffit; 4207: Dormer (Hip); 42120: Dormer (Triangle)		
Windows	4904: Segmental (Voussoirs, Plain Lug Sill, Concrete); 5903: Half-Round; 5919: Bay (2 storeys); decorative window panes		
Main Entrance	6103: Off-Centre Façade (Segmental, Voussoirs, Wood)		
Main Porch and Stairs	7104: Ground Floor, Closed Railing; 7202: Straight; 7306: Open Verandah (Piers, Wood/Brick)		
Exterior	The form, scale, and massing reflect the Four-square style with a number of architectural details and elements. The building overall is in need of refurbishing. Notably, deterioration of brickwork was observed.

Interior	N/A		
Condition	Structure: Fair. Upkeep: Fair.		
Alterations	Minimal.

History This home was first constructed in 1920. The original owner, Mr. Desantel, sold this home after the attic caught on fire. There are still visible signs of the first fire to this day. Mr. J.C. Heppler, a notary public, purchased the home, repaired the fire damage, and added brick to the house in the late 1920's. The home was originally heated by coal . the coal hatch is still visible in the basement.

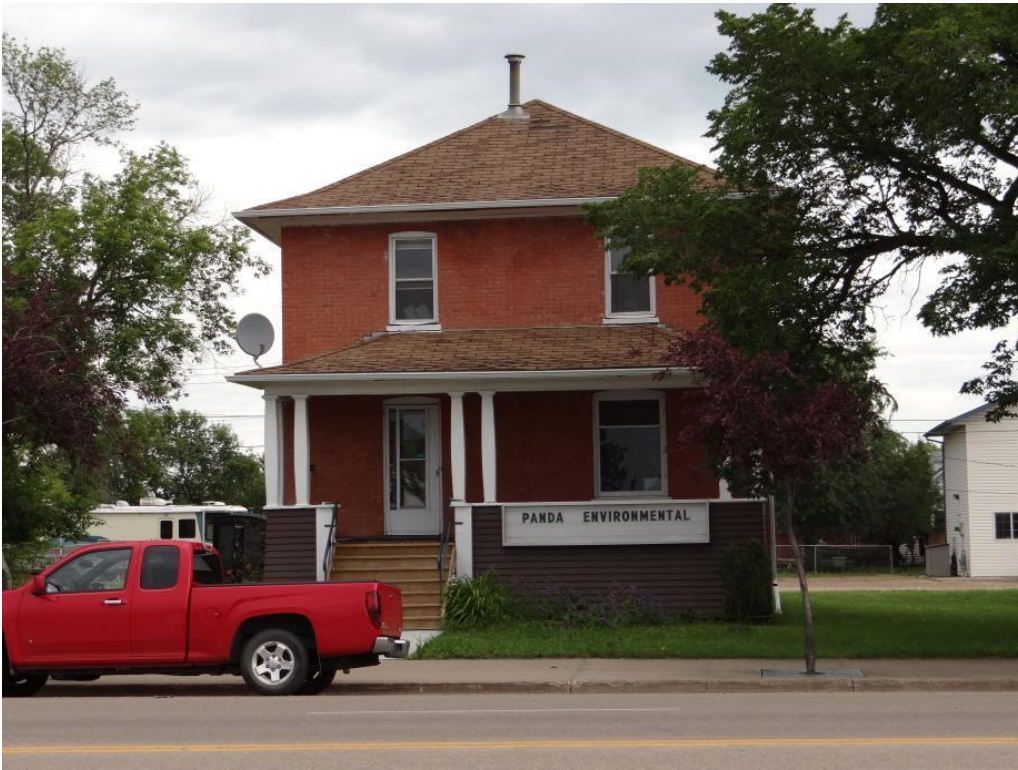
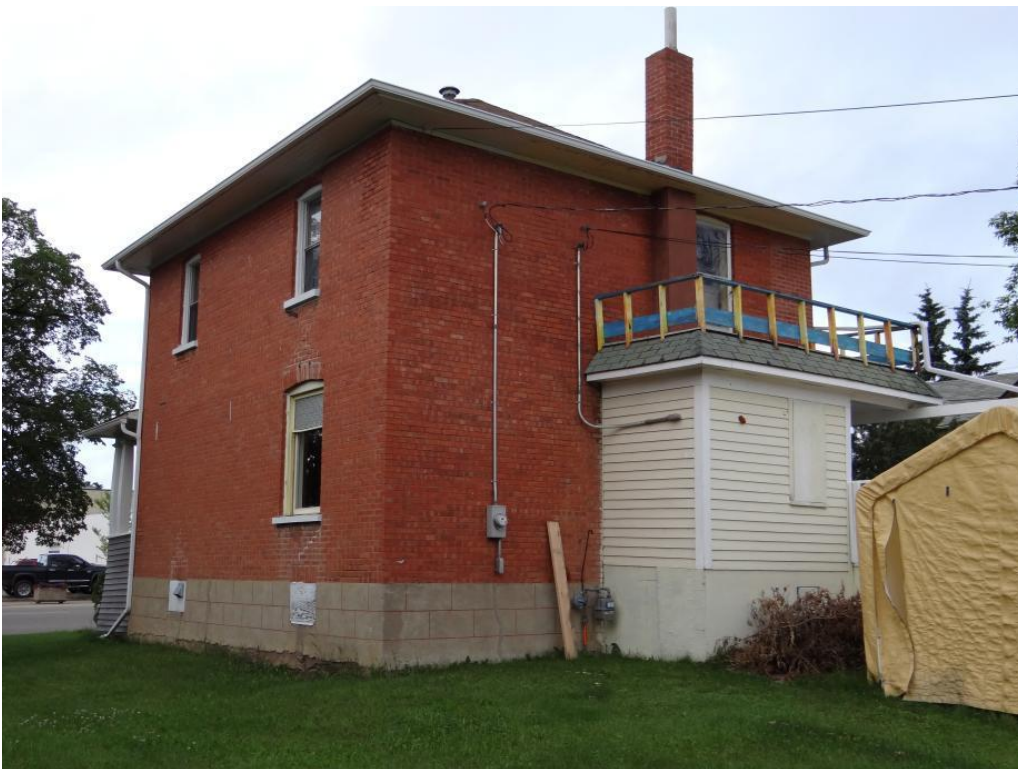
Filename	DSC00862.jpg	View	South Side
Date	July 23, 2012	Source	D. Dudzik

Architectural Style	9031: Four-square	Plan Shape	1201: Square
Storeys	1504: 2 (1707: full-above Basement)	Foundation	1807: Concrete
Superstructure	3011: Nailed Frame		
Superstructure Cover	2303: Brick (Bond: Stretcher)		
Roof Structure	3208: Medium Hip		
Roof Cover	3405: Asphalt Shingle		
Massing	1101: Single Detached	Wings	1314: Irregular
Wall Design and Detail	N/A		
Roof Detail	3512: Moulded Frieze (Wood); Chimney – Offset Left/Exterior Rear (Brick)		
Windows	4904: Segmental (Voussoirs, Plain Lug Sill)		
Main Entrance	6103: Off-Centre Façade (Segmental, Voussoirs)		
Main Porch and Stairs	7103: Ground Floor, With Railing; 7202: Straight; 7306: Open Verandah (Columns, Wood)		
Exterior	The form, scale, and massing reflect the Four-square style with a number of architectural details and elements. The building overall is in decent shape.		
Interior	N/A		
Condition	Structure: Fair. Upkeep: Good.		
Alterations	Minimal. Front steps replaced 2011.

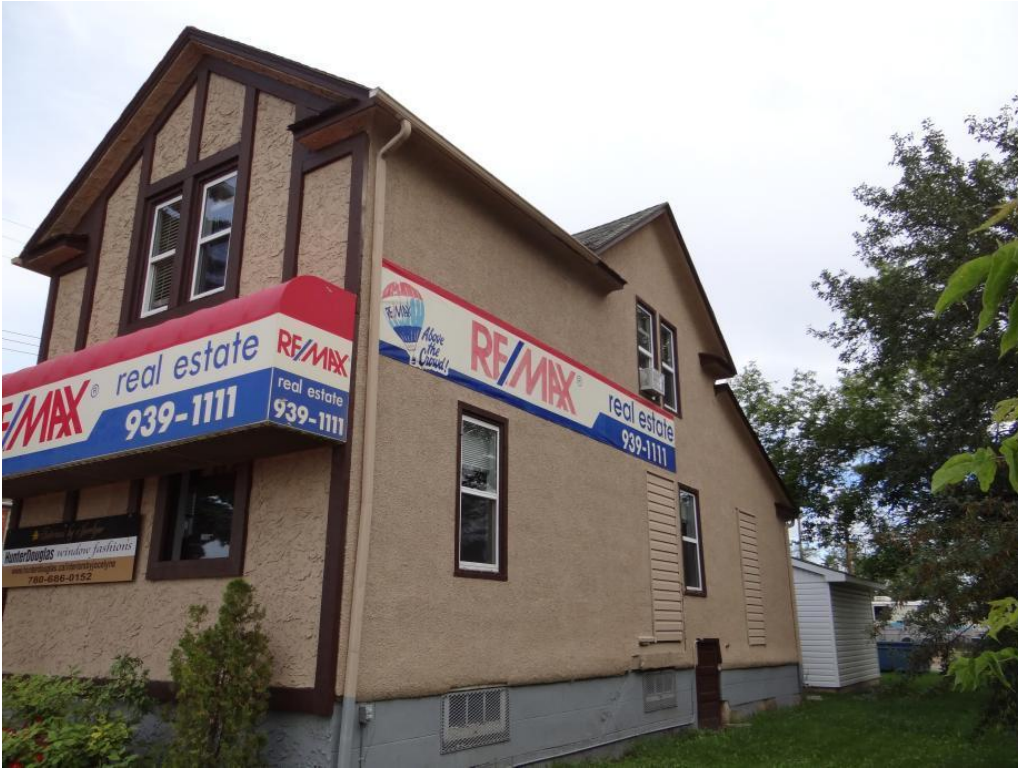
Filename DSC00867.jpg

Architectural Style	N/A	Plan Shape	1204: "L"
Storeys	1503: 1½ (1701: no Basement)	Foundation	1807: Concrete
Superstructure	3011: Nailed Frame		
Superstructure Cover	2405: Stucco		
Roof Structure	3202: Medium Gable		
Roof Cover	3405: Asphalt Shingle		
Massing	1101: Single Detached	Wings	1308: Rear
Wall Design and Detail	3116: Half-Timbering		
Roof Detail	3512: Moulded Frieze (stucco); 3716: Returned Eaves (Wood)		
Windows	4902: Flat (Plain Flat Head/Sides/Slip Sill, Wood)		
Main Entrance	6103: Off-Centre Façade (Plain Flat Head/Sides)		
Main Porch and Stairs	7103: Ground Floor, With Railing; 7202: Straight		
Exterior	The form, scale, and massing bear some elements of the Craftsman Style (half-timbering is complementary, but not likely original). The exterior finish is not original. The building is in need of refurbishing. The foundation is cracked in the rear.		
Interior	N/A		
Condition	Structure: Poor. Upkeep: Good.

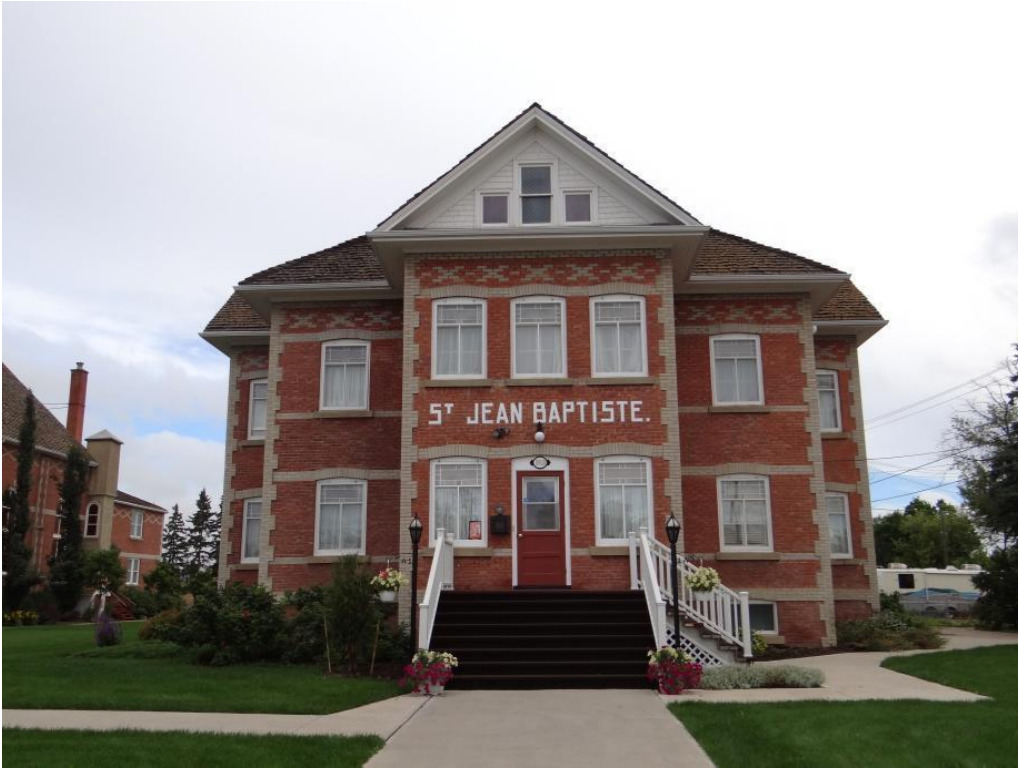
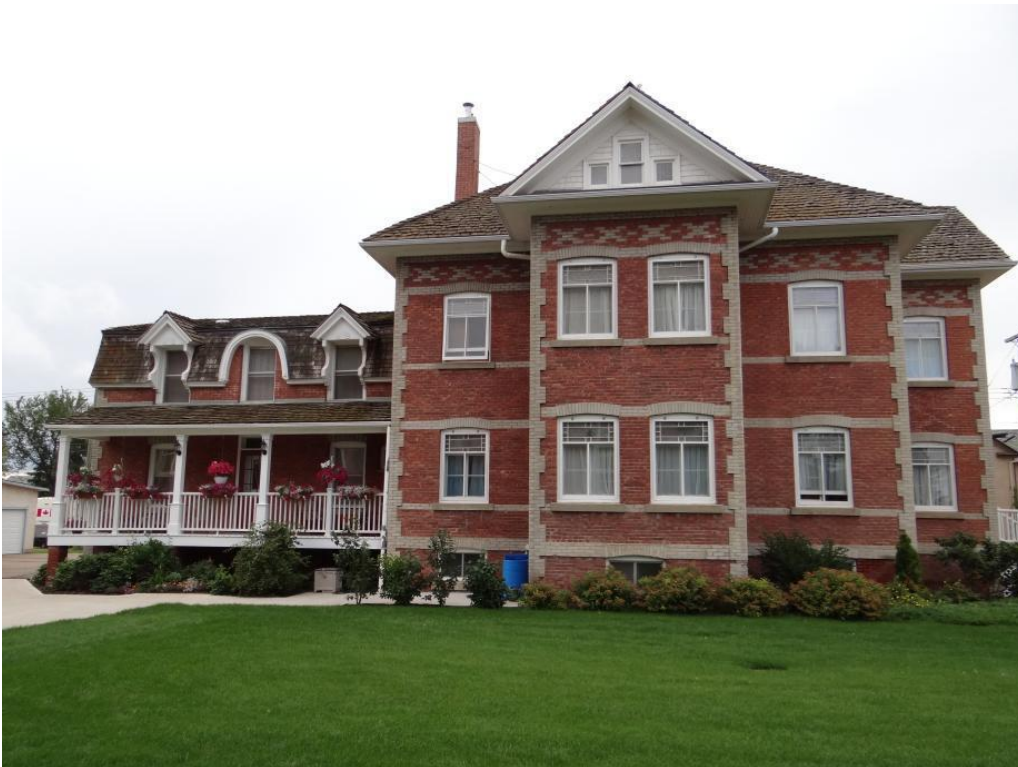
Architectural Style	N/A	Plan Shape	1212: Irregular
Storeys	1504: 2 (1707: full-above Basement)	Foundation	1806: Brick
Superstructure	3011: Nailed Frame		
Superstructure Cover	2303: Brick (Bond: Stretcher)		
Roof Structure	3214: Mansard 2 Sides / 3208: Medium Hip / 3202: Medium Gable (projections)		
Roof Cover	3501: Wood Shakes		
Massing	1101: Single Detached	Wings	1308: Rear
Wall Design and Detail	3113: Quoins; 3129: Inscription; 3131: Decorative Brick		
Roof Detail	3512: Moulded Frieze (Wood); 3717: Pediment (Wood); 4203: Dormers (Gable, Projecting Eaves – moulded verges, buttress sides); 4216: Dormer (Semi-Elliptical); Chimney – Offset Left/Rear (Brick); Statue on Pedestal		
Windows	4904: Segmental (Voussoirs, Plain Lug Sill, Decorated Panes, Stained Glass)		
Main Entrance	6102: Centre Façade; 6204: Segmental (Voussoirs)		
Main Porch and Stairs	7103: Ground Floor, With Railing; 7208: Straight/Side; 7306: Open Verandah (Columns, Wood/Brick)

Exterior	Reflects many of the features of the Church such as decorative masonry. Defining features include the roof with cross gables and crowning statue, along with the inscription above the door.		
Interior	N/A		
Condition	Structure: Good. Upkeep: Good.		
Alterations	First rectory a log structure built in 1895, moved and joined to second building in 1912. This building was faced with brick in late 1920s. Extensive restoration project carried out in 1973.

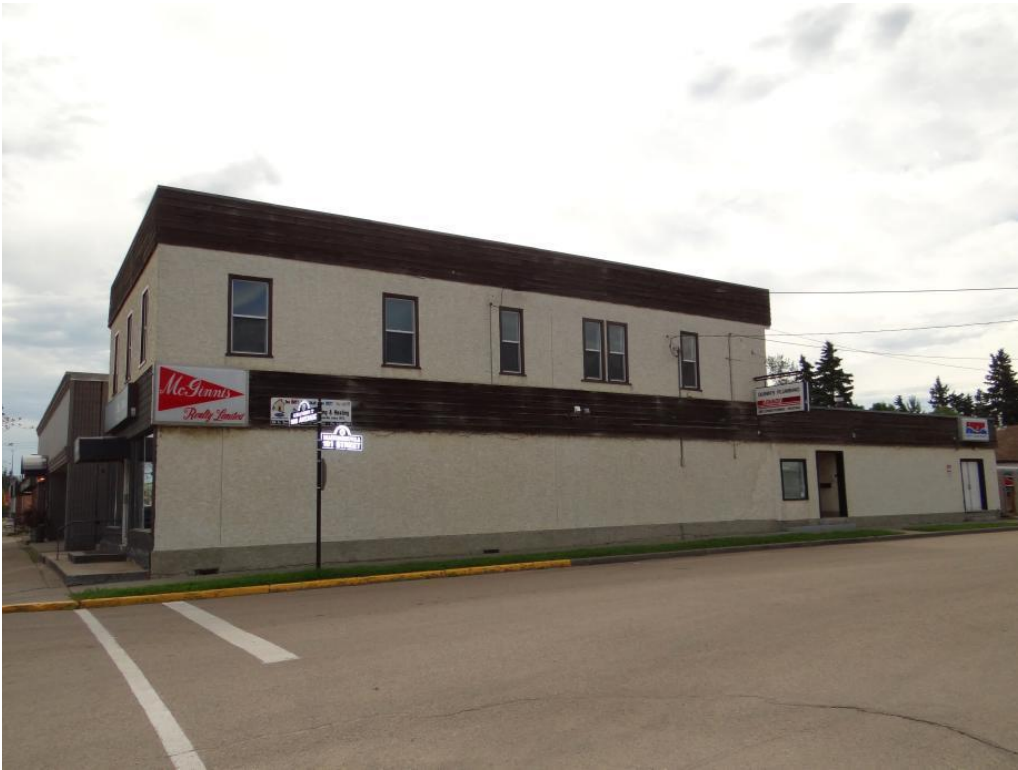
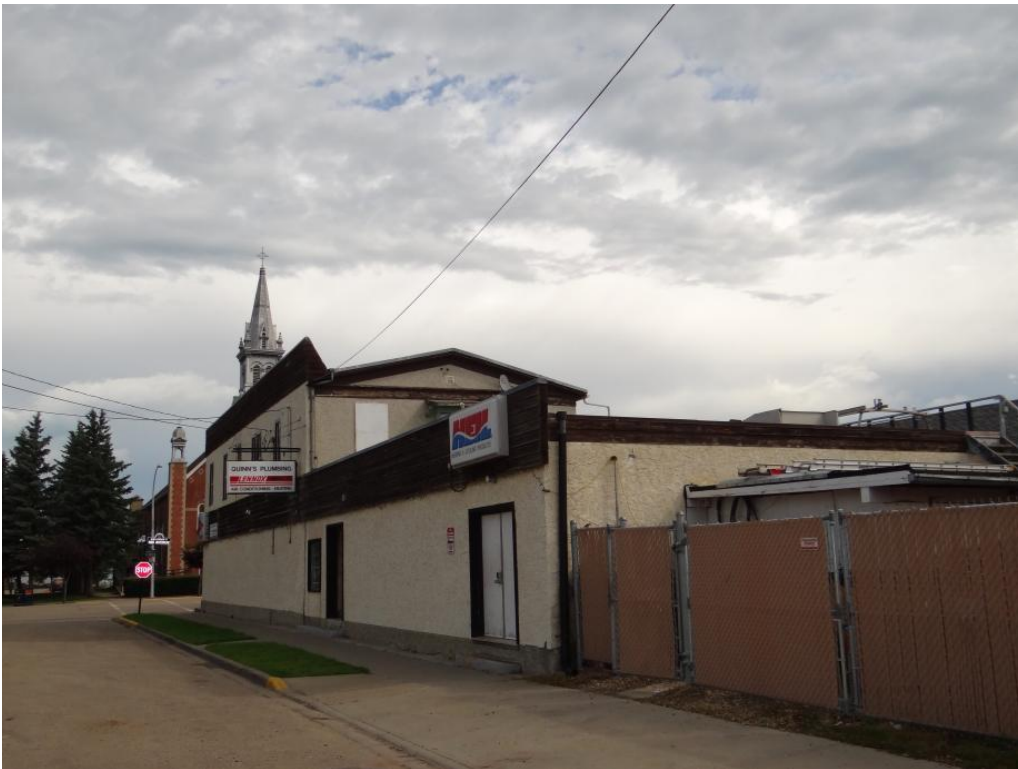
Filename	DSC00823.jpg	View	NW Corner
Date	July 23, 2012	Source	D. Dudzik

Architectural Style	N/A	Plan Shape	1203: Rectangular Short Façade
Storeys	1504: 2 (1701: no Basement)	Foundation	1807: Concrete
Superstructure	3011: Nailed Frame		
Superstructure Cover	2405: Stucco / 2011: Wood (Shiplap)		
Roof Structure	3219: Flat		
Roof Cover	3401: Unknown		
Massing	1106: Row, Non-Related, End	Wings	1308: Rear
Wall Design and Detail	N/A		
Roof Detail	N/A		
Windows	4902: Flat (Plain Lug Sill)		
Main Entrance	N/A		
Main Porch and Stairs	N/A		
Exterior	The form, scale, and massing are a unique character for a commercial building, however the details may not be original.		
Interior	N/A		
Condition	Structure: Fair. Upkeep: Fair.		
Alterations	Exterior refinished.

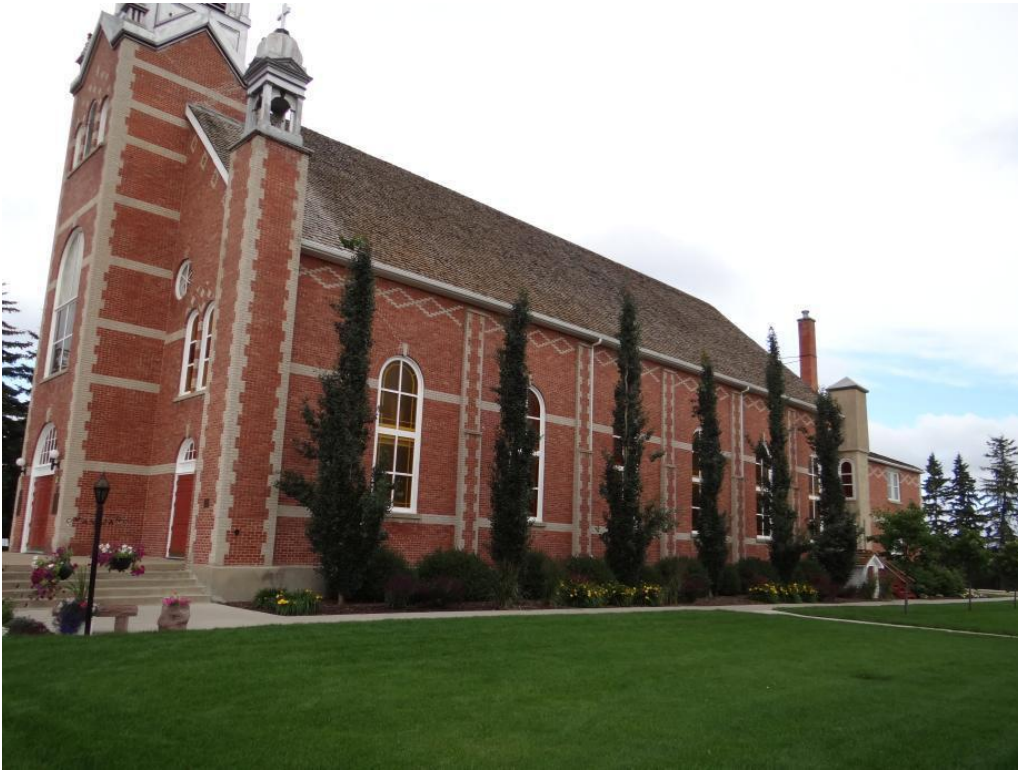
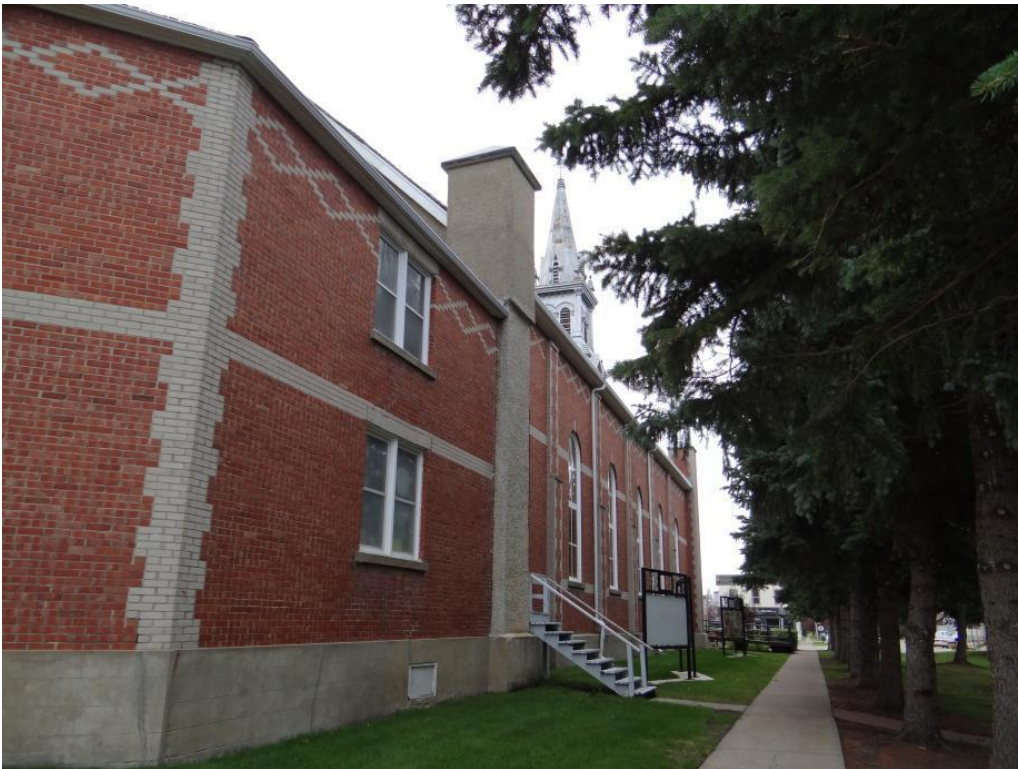
Filename	DSC00882.jpg	View	SE Corner
Date	July 24, 2012	Source	D. Dudzik

Architectural Style	9022: French Canadian	Plan Shape	1213: Rectangular with Apse
Storeys	1504: 2 (1708: full-below Basement)	Foundation	1806: Brick
Superstructure	3011: Nailed Frame		
Superstructure Cover	2303: Brick (Bond: Stretcher)		
Roof Structure	3203: High Gable / 3226: Polygonal		
Roof Cover	3501: Wood Shakes		
Massing	1101: Single Detached	Wings	1308: Rear
Wall Design and Detail	3107: Pilaster; 3113: Quoins; 3131: Decorative Brick		
Roof Detail	3705: Plain Fascia (Wood); 3903: Towers – Exterior Front/Left & Right (Spire); 3904: Steeple – Exterior Front/Centre (Cupola); Chimney – Offset Left/Exterior Rear (Brick)		
Windows	4906: Semi-Circular (Keystone, Voussoirs, Plain Lug Sill – Concrete; Moulded, Shaped Transom (Multiple Lights), Round, Stained Glass; Blind alcove (Statue))		
Main Entrance	6105: 3 Façade; 6206: Semi-Circular (Keystone – Concrete); Shaped Transom (Multiple Lights); Two Leaves

Main Porch and Stairs	7102: Ground Floor, Without Railing; 7208: All-directional		
Exterior	Elaborate and ornate ecclesiastical style with tall central spire and towers topped with pinnacles and domes crowned with crosses, decorative masonry, Romanesque Revival window arches, and High Victorian Gothic features.		
Interior	Ornately carved elements and murals, barrel vault over the nave and semi-dome over the apse.		
Condition	Structure: Good. Upkeep: Good.		
Alterations	1929 – Brick façade. Extensive restoration project carried out in 1973.

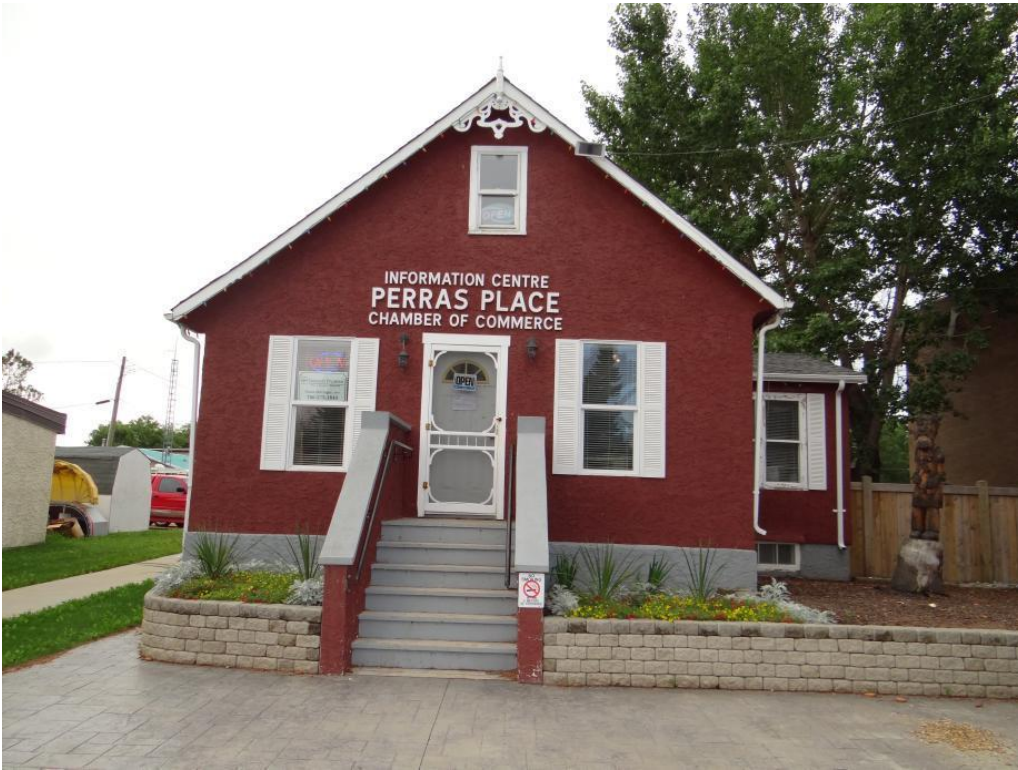
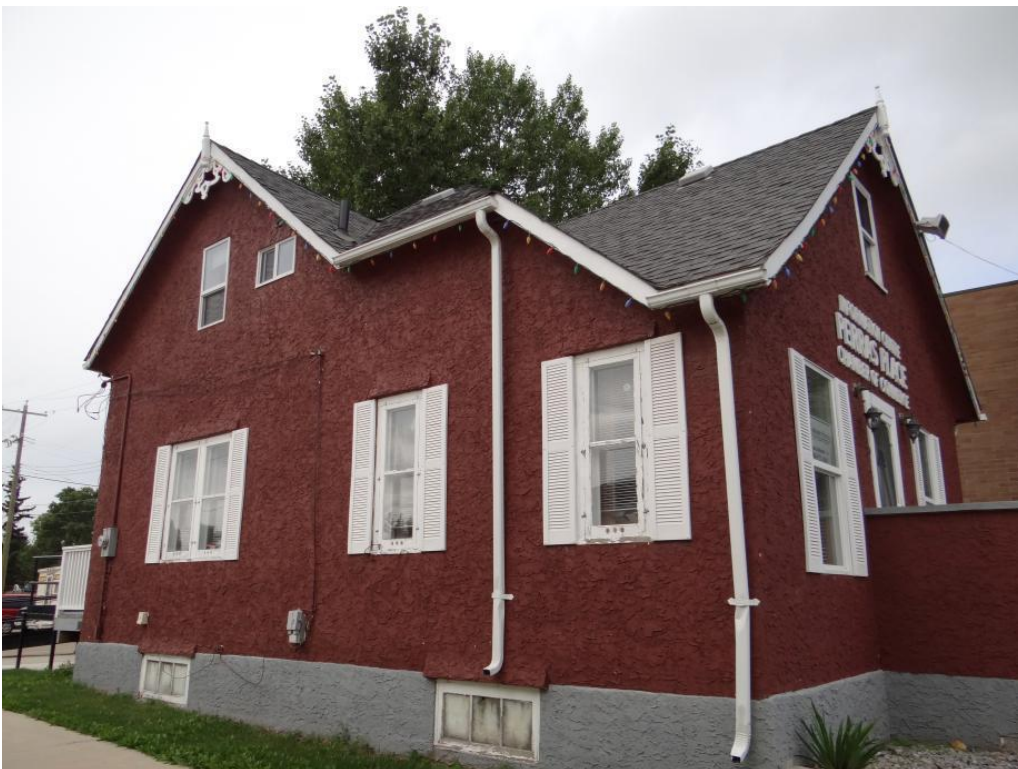
Filename DSC00891.jpg

Architectural Style	N/A	Plan Shape	1212: Irregular
Storeys	1502: 1 (1708: full-below Basement)	Foundation	1807: Concrete
Superstructure	3011: Nailed Frame		
Superstructure Cover	2405: Stucco		
Roof Structure	3202: Medium Gable		
Roof Cover	3405: Asphalt Shingle		
Massing	1101: Single Detached	Wings	1305: Front and Right
Wall Design and Detail	N/A		
Roof Detail	3512: Moulded Frieze (stucco); 3707: Decorated Fascia; 4207: Dormer (Hip); Chimney – Offset Right/Exterior Rear (Brick)		
Windows	4902: Flat (Plain Flat Head/Sides/Lug Sill, Wood, Shutters)		
Main Entrance	6103: Off-Centre Façade (Flat, Plain Lintel/Sides, Wood)		
Main Porch and Stairs	7104: Ground Floor, Closed Railing; 7202: Straight; 7302: Platform)		
Exterior	The exterior finish is not original. A number of components have been altered or added and would bear little resemblance to the original home.		
Interior	N/A		
Condition	Structure: Good. Upkeep: Good.

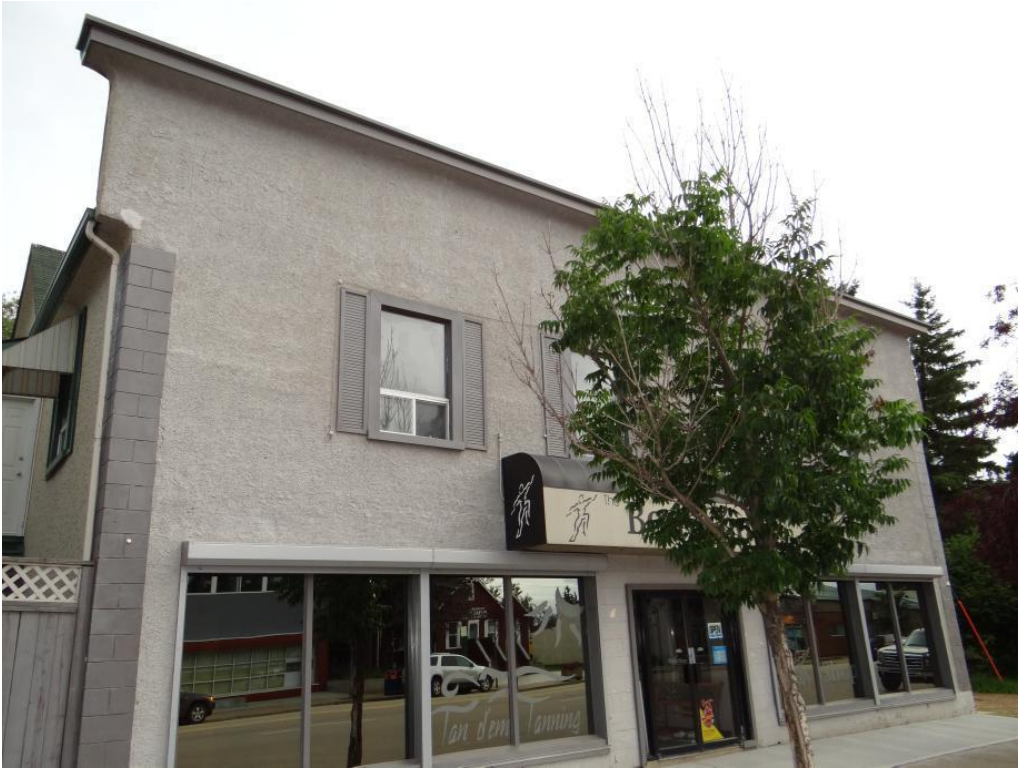
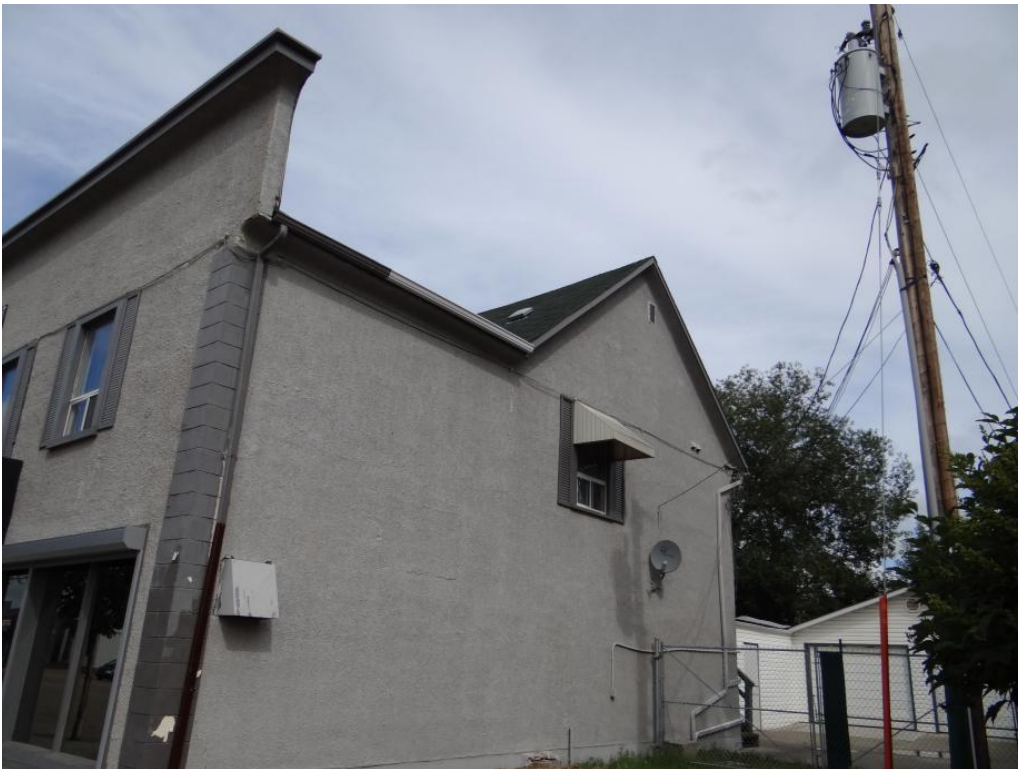
Filename	DSC00907.jpg	View	SW Corner
Date	July 24, 2012	Source	D. Dudzik

Architectural Style	N/A	Plan Shape	1201: Square
Storeys	1504: 2 (1701: no Basement)	Foundation	1807: Concrete
Superstructure	3011: Nailed Frame		
Superstructure Cover	2405: Stucco		
Roof Structure	3202: Medium Gable / 3219: Flat		
Roof Cover	3405: Asphalt Shingle		
Massing	1101: Single Detached	Wings	1314: Irregular
Wall Design and Detail	3113: Quoins (Block); 3135: Upper Storey Door; 3138: False Front		
Roof Detail	3512: Moulded Frieze (stucco)		
Windows	4902: Flat (Plain Flat Head/Sides/Slip Sill (Wood), Shutters)		
Main Entrance	6102: Centre Façade (Plain Flat Head/Sides – wide, Two Leaves)		
Main Porch and Stairs	N/A		
Exterior	The form, scale, and massing are characteristic of the Boomtown style, however details other than the false front are not original to the building.		
Interior	N/A		
Condition	Structure: Good. Upkeep: Good.		
Alterations	Extensive alterations to the exterior have been undertaken.

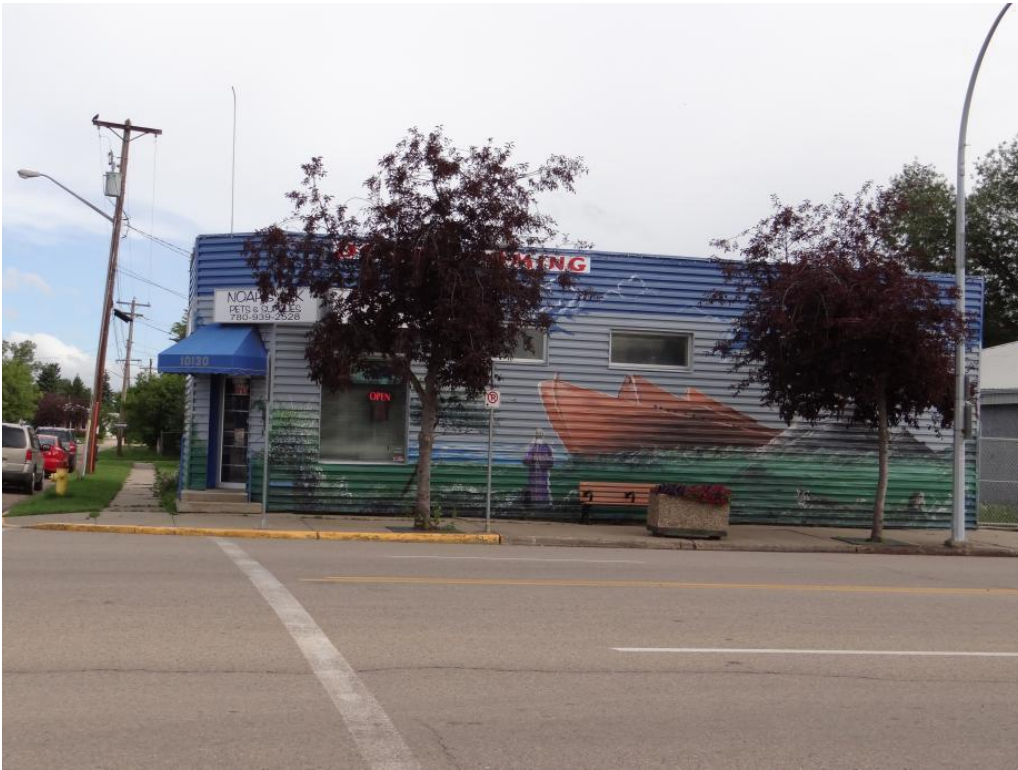
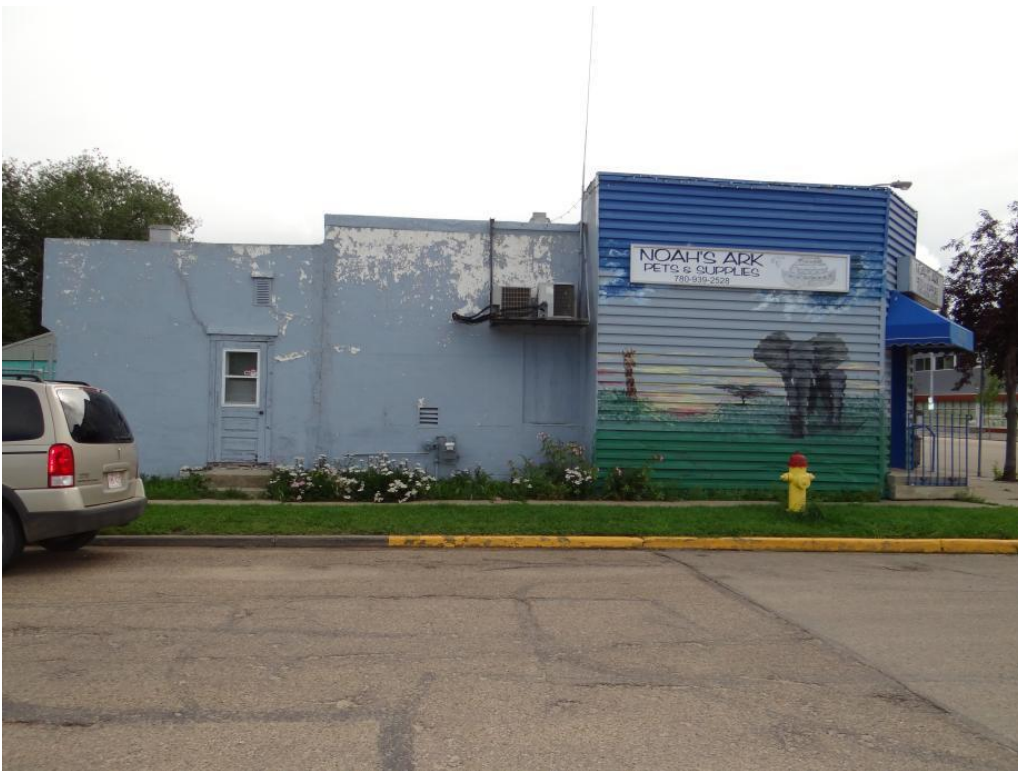
Filename	DSC00897.jpg	View	South Side
Date	July 24, 2012	Source	D. Dudzik

Architectural Style	N/A	Plan Shape	1202: Rectangular Long Façade
Storeys	1502: 1 (1701: no Basement)	Foundation	1807: Concrete
Superstructure	3011: Nailed Frame		
Superstructure Cover	2605: Metal Siding (2303: Brick (Bond: Stretcher) beneath)		
Roof Structure	3219: Flat		
Roof Cover	3401: Unknown		
Massing	1101: Single Detached	Wings	1314: Irregular
Wall Design and Detail	3137: Other (Mural)		
Roof Detail	4710: Raised Fire Wall		
Windows	4902: Flat (Flat Transom, Single Light)		
Main Entrance	6104: Corner		
Main Porch and Stairs	7103: Ground Floor, Open Railing; 7202: Straight		
Exterior	The form, scale, and massing are a unique character for a commercial building, however the original brick walls are covered and an attractive mural was painted onto the metal siding.		
Interior	N/A		
Condition	Structure: Fair. Upkeep: Fair.		
Alterations	Extensive alterations to the exterior have been undertaken.

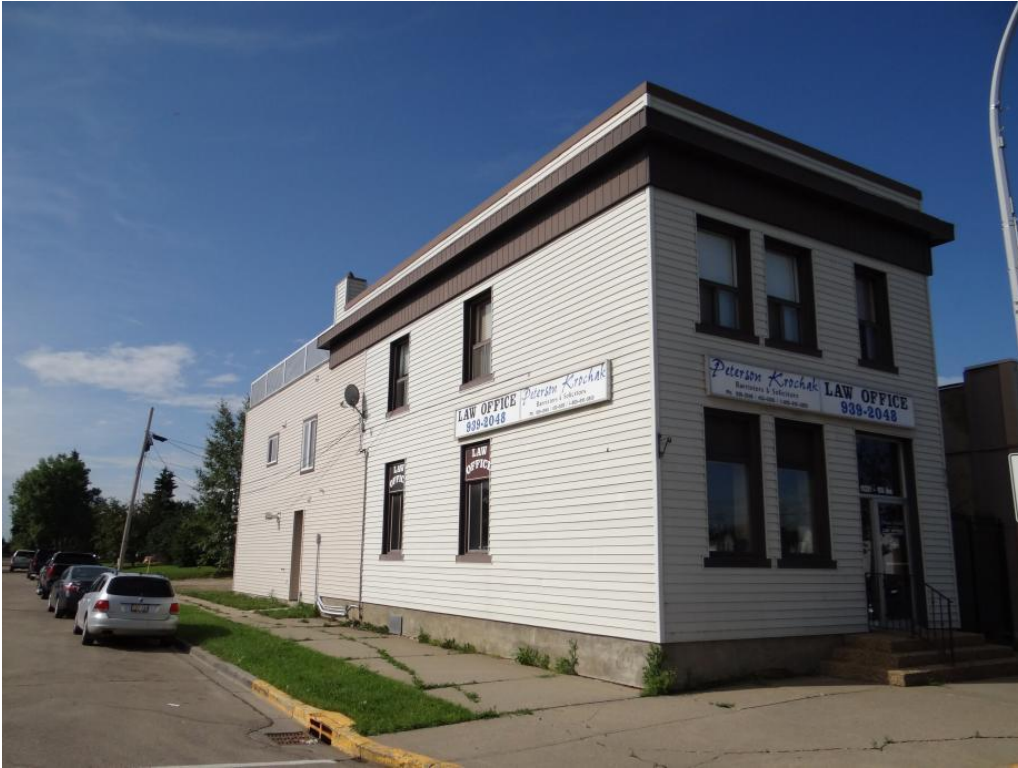
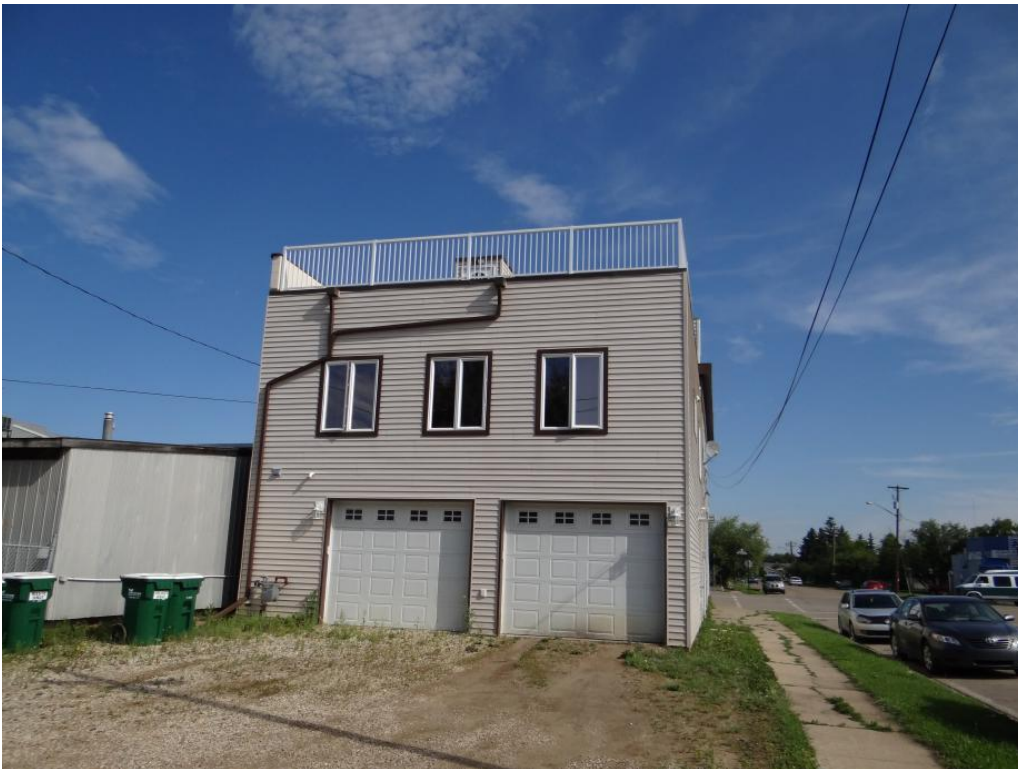
Filename	DSC00730.jpg	View	NE Corner
Date	July 18, 2012	Source	D. Dudzik

Architectural Style	N/A	Plan Shape	1203: Rectangular Short Façade
Storeys	1504: 2 (1701: no Basement)	Foundation	1807: Concrete
Superstructure	3011: Nailed Frame		
Superstructure Cover	2408: Vinyl (2303: Brick (Bond: Stretcher) beneath)		
Roof Structure	3219: Flat		
Roof Cover	3401: Unknown		
Massing	1106: Row, Non-Related, End	Wings	1308: Rear
Wall Design and Detail	3121: Entablature		
Roof Detail	3502: Flush Eaves (Metal); Chimney – Side Left/Rear (Brick)		
Windows	4902: Flat (Plain Lug Sill, Metal, Flat Transom, Single Light)		
Main Entrance	6103: Off-Centre Façade (Flat Transom, Single Light, Side Light)		
Main Porch and Stairs	7103: Ground Floor, Open Railing; 7208: Other (rounded)		
Exterior	The form, scale, and massing are a unique character for a commercial building, however the original brick walls are covered with siding. The addition is sided to match the siding.		
Interior	N/A		
Condition	Structure: Fair. Upkeep: Fair.

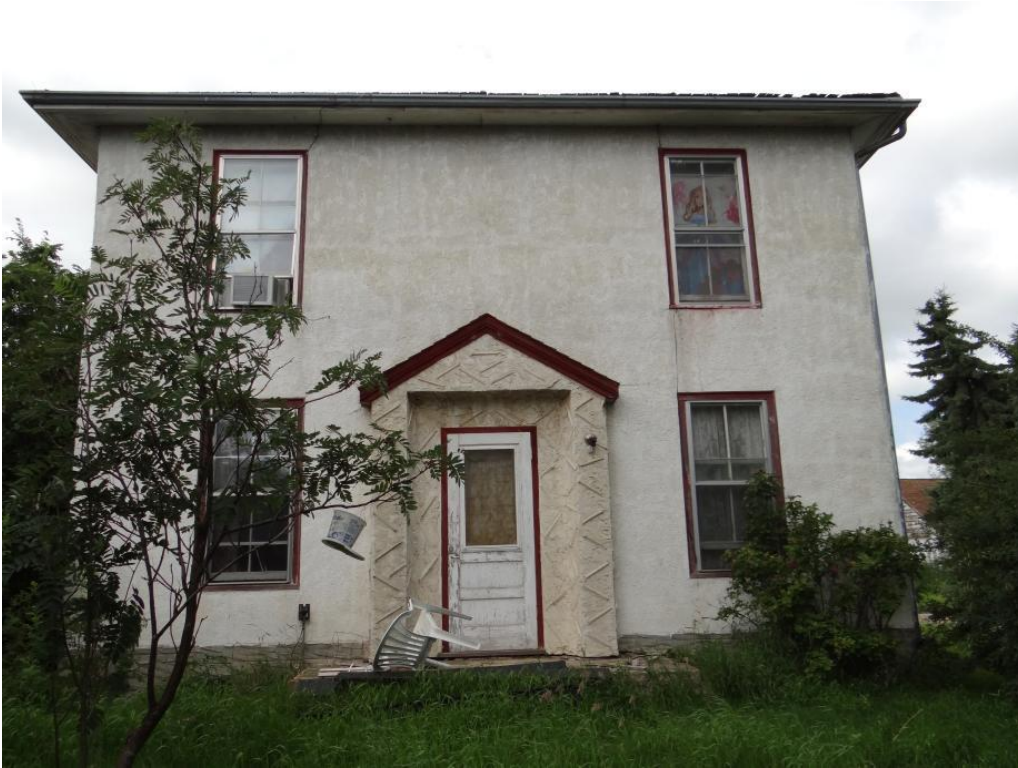
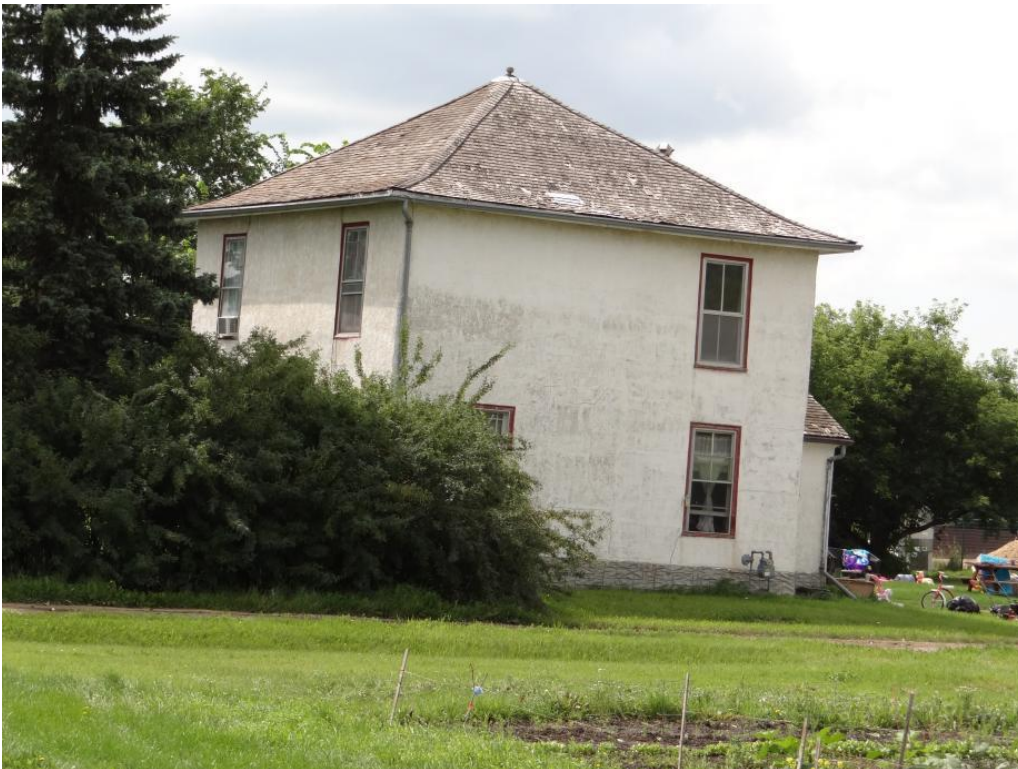
Filename	DSC00995.jpg	View	East Side
Date	July 25, 2012	Source	D. Dudzik

Architectural Style	9031: Four-square	Plan Shape	1201: Square
Storeys	1504: 2 (1708: full-below Basement)	Foundation	1807: Concrete
Superstructure	3011: Nailed Frame		
Superstructure Cover	2405: Stucco		
Roof Structure	3206: Pyramidal		
Roof Cover	3501: Wood Shakes		
Massing	1101: Single Detached	Wings	N/A
Wall Design and Detail	3503: Projecting Eaves (Wood)		
Roof Detail	4704: Finial (ball)		
Windows	4902: Flat (Plain Flat Head, Moulded Sides, Plain Slip Sill, Wood)		
Main Entrance	6102: Centre Façade (Plain Pedement, Moulded Head/Sides, Shaped Panel)		
Main Porch and Stairs	7102: Ground Floor, Without Railing; 7202: Straight; 7305 (Rear Closed Porch)		
Exterior	The form, scale, and massing reflect the Four-square style. The exterior finish is not original, and details around main entrance may not be original. The building overall is in need of refurbishing.		
Interior	N/A		
Condition	Structure: Fair. Upkeep: Fair. Zoned UR District (discretionary use).

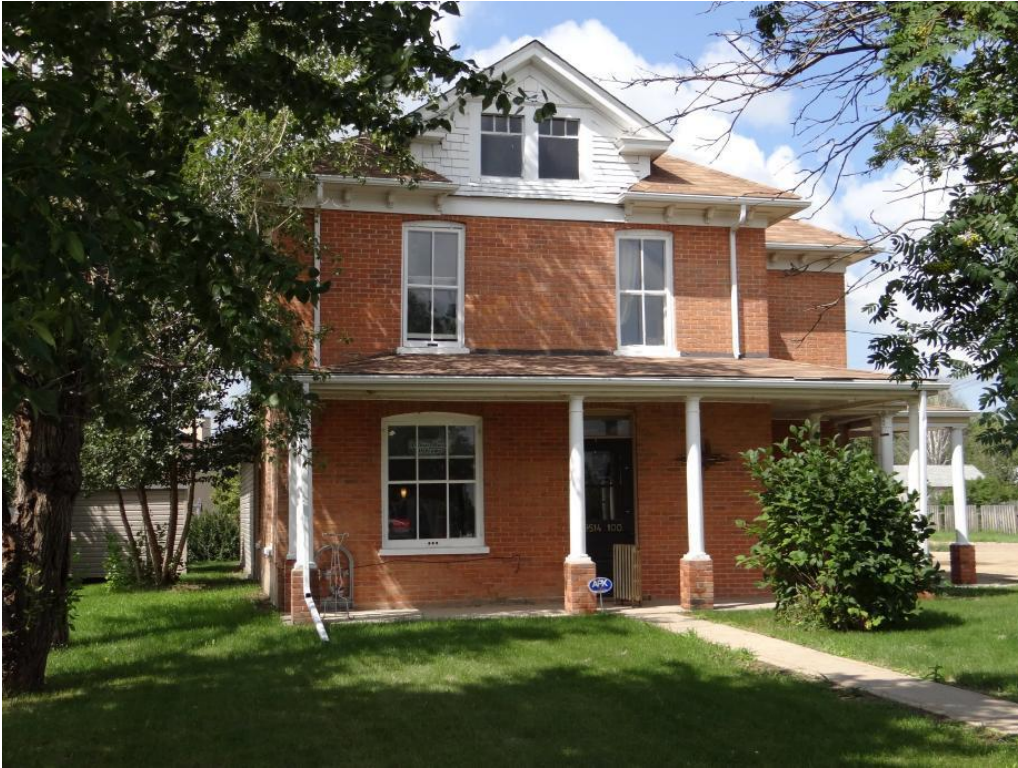
Filename	DSC00991.jpg	View	East Side
Date	July 25, 2012	Source	D. Dudzik

Architectural Style	9031: Four-square	Plan Shape	1204: "L"
Storeys	1504: 2 (1708: full-below Basement)	Foundation	1807: Concrete
Superstructure	3011: Nailed Frame		
Superstructure Cover	2303: Brick (Bond: Stretcher)		
Roof Structure	3208: Medium Hip		
Roof Cover	3405: Asphalt Shingle		
Massing	1101: Single Detached	Wings	1308: Rear
Wall Design and Detail	N/A		
Roof Detail	3512: Moulded Frieze; 3514: Brackets; 4204: Dormer (Gable, Returning Eaves)		
Windows	4904: Segmental (Voussoirs, Plain Lug Sill, Wood, Moulded Within)		
Main Entrance	6103: Off-Centre Façade (Segmental, Voussoirs, Moulded Head/Sides, Flat Transom – Single Light & Blind, Shaped Panel)		
Main Porch and Stairs	7306: Open Verandah (Columns, Wood/Brick)		
Exterior	The form, scale, and massing reflect the Four-square style with a number of architectural details and elements. The building overall is in good shape.		
Interior	N/A		
Condition	Structure: Good. Upkeep: Good.
