# Morinville Heritage Survey

FINAL REPORT | May 2013

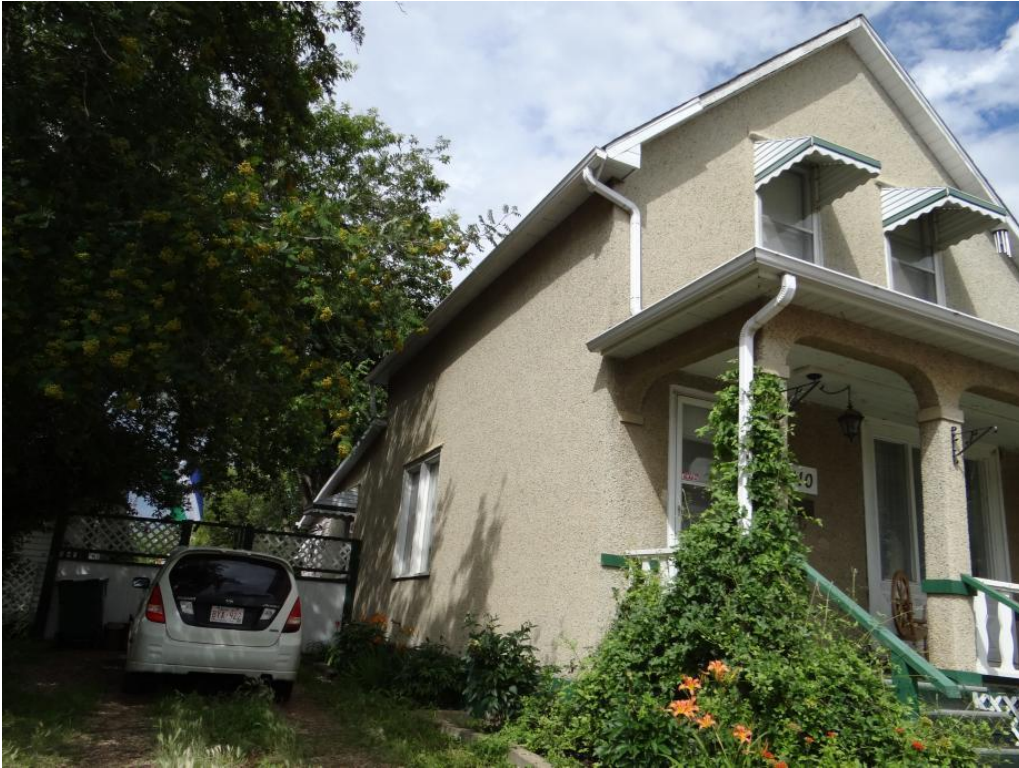
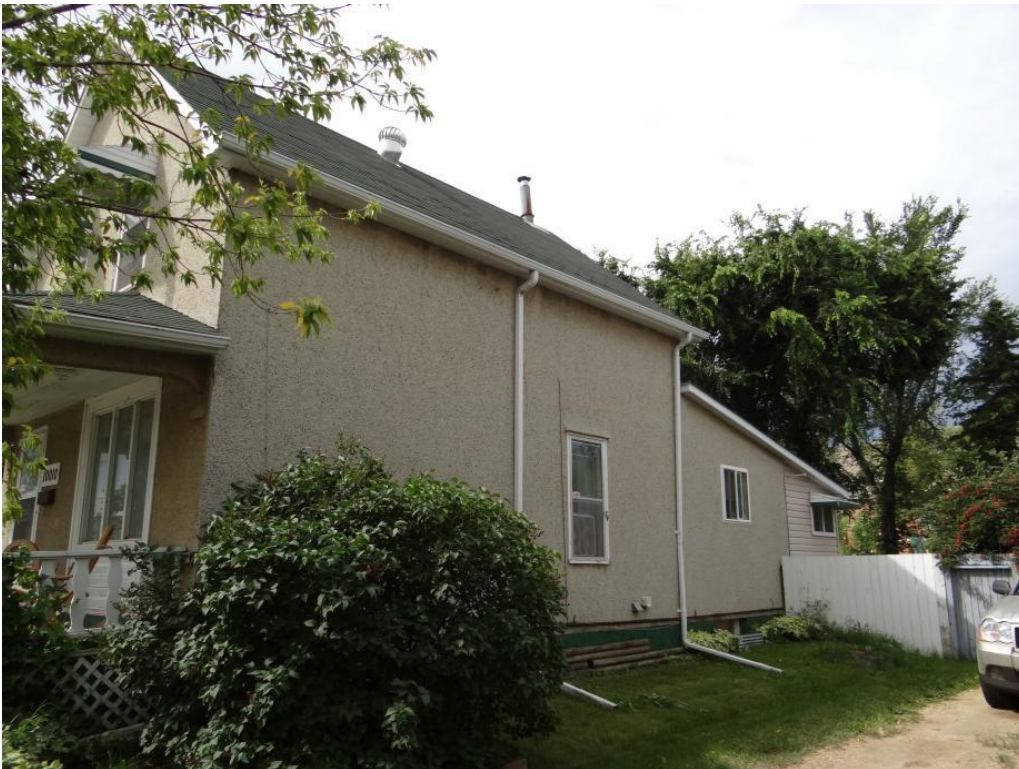
Filename	DSC00843.jpg	View	SE Corner
Date	July 23, 2012	Source	D. Dudzik

Architectural Style	N/A	Plan Shape	1203: Rectangular Short Façade
Storeys	1503: 1½ (1708: full-below Basement)	Foundation	1807: Concrete
Superstructure	3011: Nailed Frame		
Superstructure Cover	2405: Stucco		
Roof Structure	3202: Medium Gable		
Roof Cover	3405: Asphalt Shingle		
Massing	1101: Single Detached	Wings	1308: Rear
Wall Design and Detail	N/A		
Roof Detail	N/A		
Windows	4902: Flat (Moulded Lintel, Decorated Slip Sill, Moulded Head/Sides Within)		
Main Entrance	6103: Off-Centre Façade		
Main Porch and Stairs	7103: Ground Floor, With Railing; 7202: Straight; 7306: Open Verandah (Columns, Arches, Wood/Stucco)		
Exterior	The form, scale, and massing bear some elements of the Craftsman Style. The exterior finish and metal-frame windows are not original.		
Interior	N/A		
Condition	Structure: Good. Upkeep: Fair. Zoned C-2 District (discretionary use).		
Alterations	Addition of wing c. 1960.

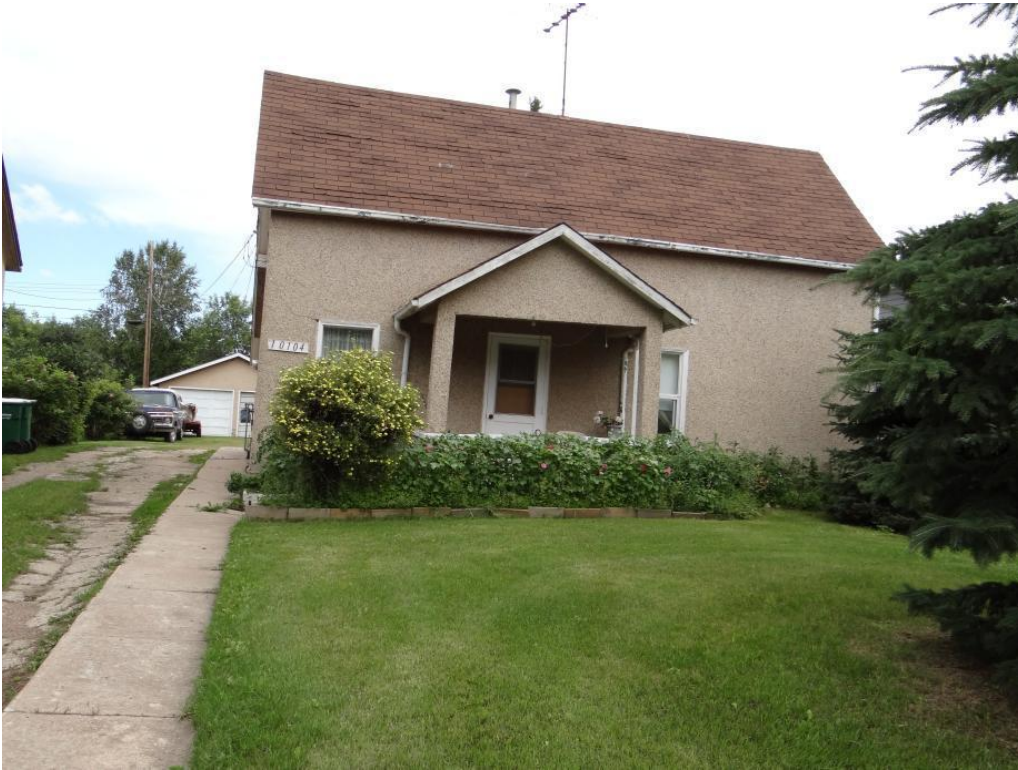
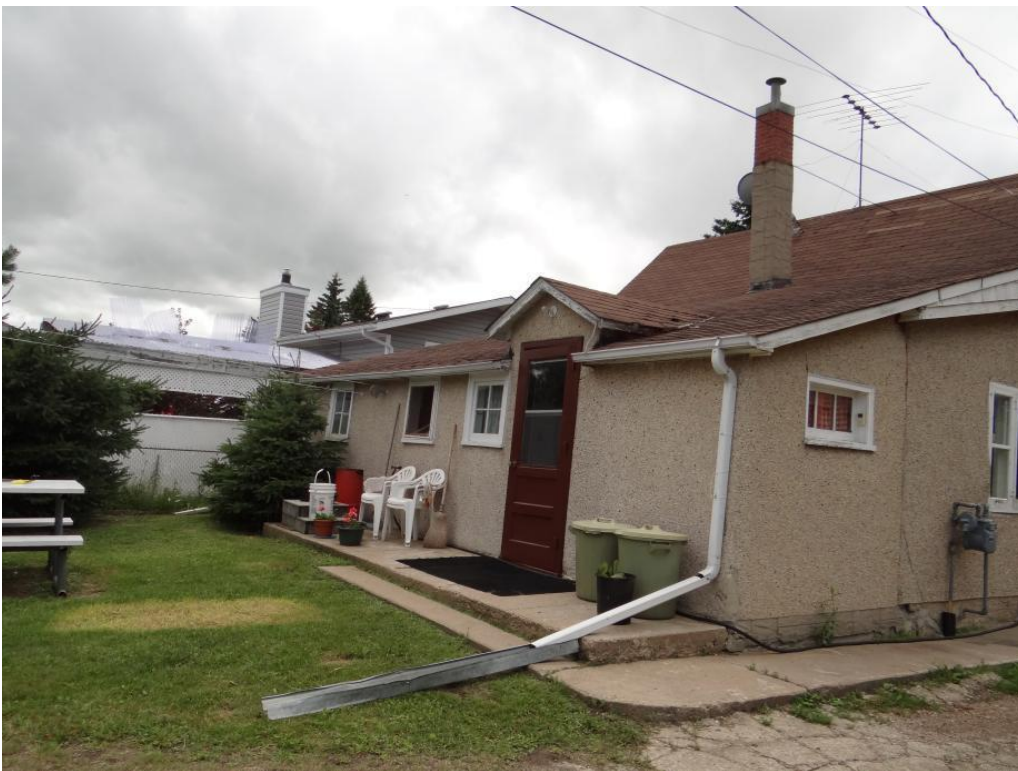
Filename	DSC00917.jpg	View	South Side
Date	July 24, 2012	Source	D. Dudzik

Architectural Style	N/A	Plan Shape	1202: Rectangular Long Façade
Storeys	1503: 1½ (1701: no Basement)	Foundation	1807: Concrete
Superstructure	3011: Nailed Frame		
Superstructure Cover	2405: Stucco		
Roof Structure	3202: Medium Gable		
Roof Cover	3405: Asphalt Shingle		
Massing	1101: Single Detached	Wings	1308: Rear
Wall Design and Detail	N/A		
Roof Detail	3503: Projecting Eaves (Wood); 3703: Projecting Verges; Chimney – Centre Side-to-Side/Exterior Rear (Brick/Concrete); 3311: Dormer Door		
Windows	4902: Flat (Plain Lug Sill, Wood, Moulded Head/Sides Within)		
Main Entrance	6103: Off-Centre Façade		
Main Porch and Stairs	7304: Open Porch (Posts, Closed Railing, Wood/Stucco)		
Exterior	The exterior finish is not original. A number of components have been altered and would bear little resemblance to the original home.		
Interior	N/A		
Condition	Structure: Poor. Upkeep: Poor.		
Alterations	Additions built c. 1913. Exterior refinished.

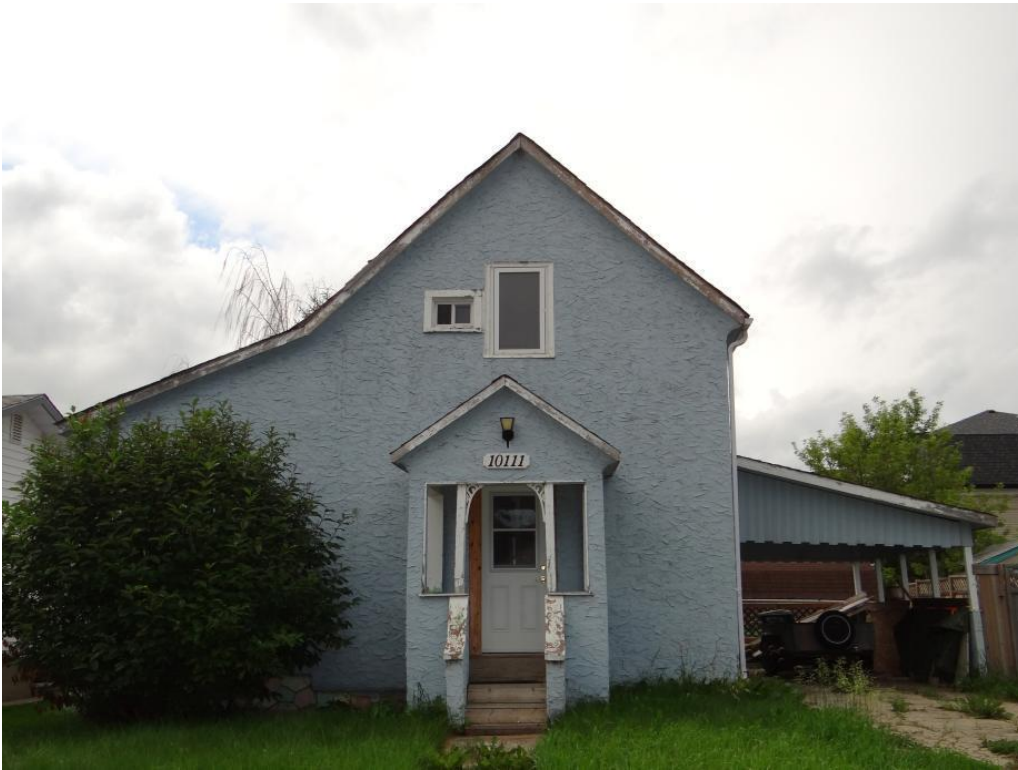
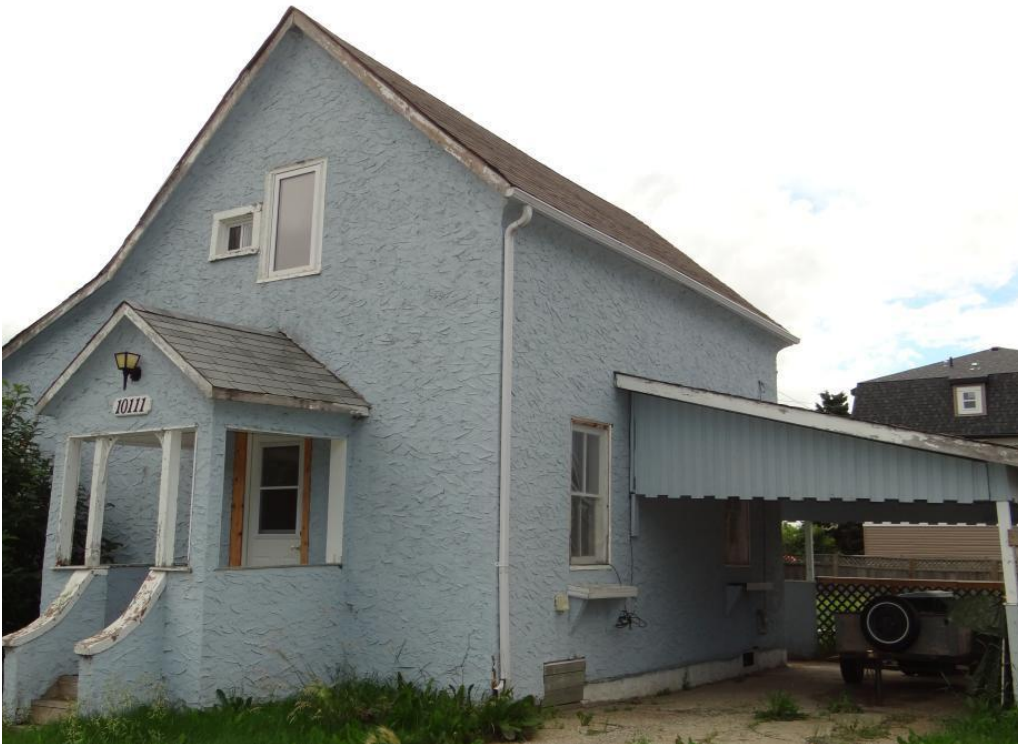
Filename	DSC00923.jpg	View	North Side
Date	July 24, 2012	Source	D. Dudzik

Architectural Style	N/A	Plan Shape	1203: Rectangular Short Façade
Storeys	1503: 1½ (1708: full-below Basement)	Foundation	1807: Concrete
Superstructure	3011: Nailed Frame		
Superstructure Cover	2014: Clapboard (Drop Siding)		
Roof Structure	3202: Medium Gable		
Roof Cover	3405: Asphalt Shingle		
Massing	1101: Single Detached	Wings	N/A
Wall Design and Detail	3115: Corner Board		
Roof Detail	3513: Decorated Frieze (Wood); 3703: Projecting Verges (Wood); Chimney – Side Right/Centre		
Windows	4902: Flat (Plain Flat Head/Sides/Slip Sill, Wood)		
Main Entrance	6106: Not on Façade		
Main Porch and Stairs	N/A		
Exterior	The form, scale, and massing bear some elements of the Craftsman Style. The exterior finish is not original. A number of components have been altered and would bear little resemblance to the original home.		
Interior	N/A		
Condition	Structure: Fair. Upkeep: Fair.		
Alterations	Extensive renovations c. 1994.

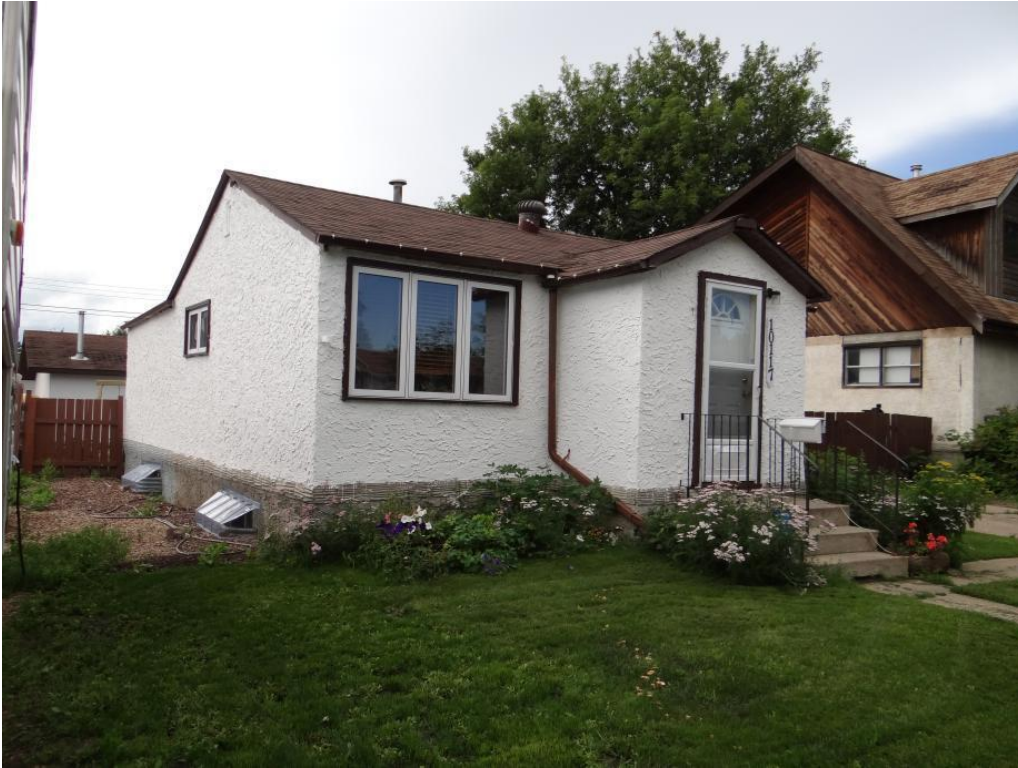
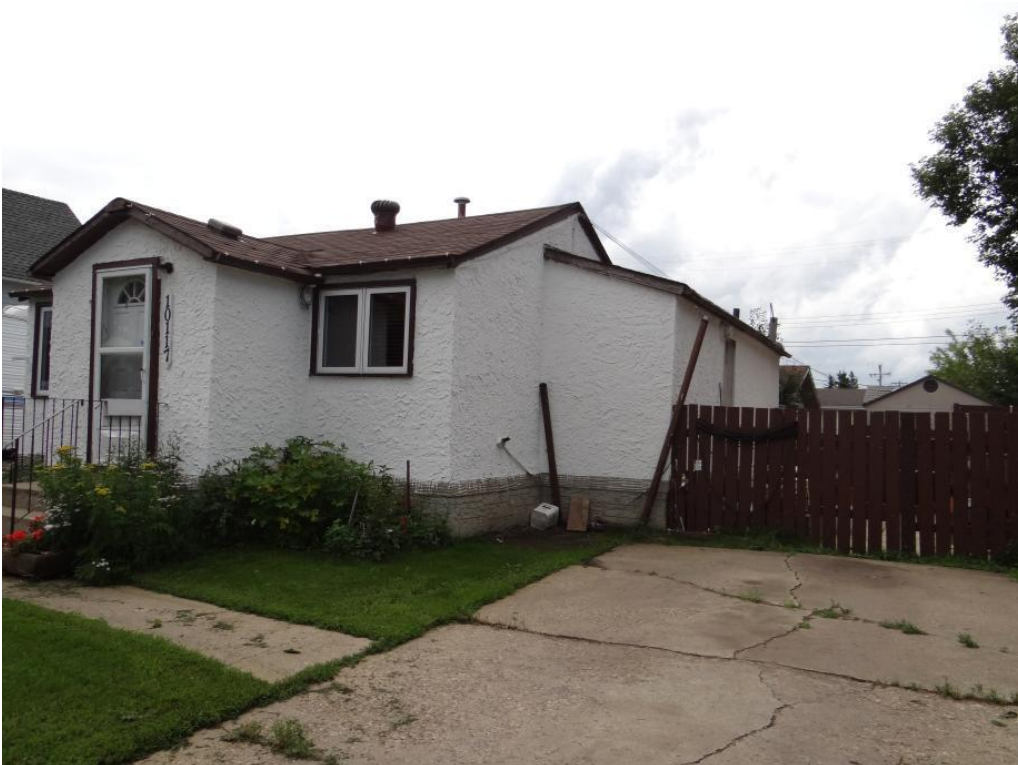
Filename	DSC00932.jpg	View	NE Corner
Date	July 24, 2012	Source	D. Dudzik

Architectural Style	N/A	Plan Shape	1203: Rectangular Short Façade
Storeys	1503: 1½ (1701: no Basement)	Foundation	1807: Concrete
Superstructure	3011: Nailed Frame		
Superstructure Cover	2405: Stucco		
Roof Structure	3203: High Gable		
Roof Cover	3405: Asphalt Shingle (red)		
Massing	1101: Single Detached	Wings	1304: Side (Right)
Wall Design and Detail	N/A		
Roof Detail	3512: Moulded Frieze (stucco); 3703: Projecting Verges (wood); 4211: Dormer (Shed – large); Chimney – Offset Right/Rear (Brick)		
Windows	4902: Flat (Plain Flat Head, Plain Sides, Wood); Small Attic		
Main Entrance	6103: Off–Centre Façade (Shaped Panel)		
Main Porch and Stairs	7102: Ground Floor, Without Railing; 7202: Straight; 7305: Closed Porch (recessed)		
Exterior	The form, scale, and massing bear some elements of the Craftsman Style. The exterior finish is not original.		
Interior	N/A		
Condition	Structure: Good. Upkeep: Good.		
Alterations	Extensive restoration carried out c. 1961.

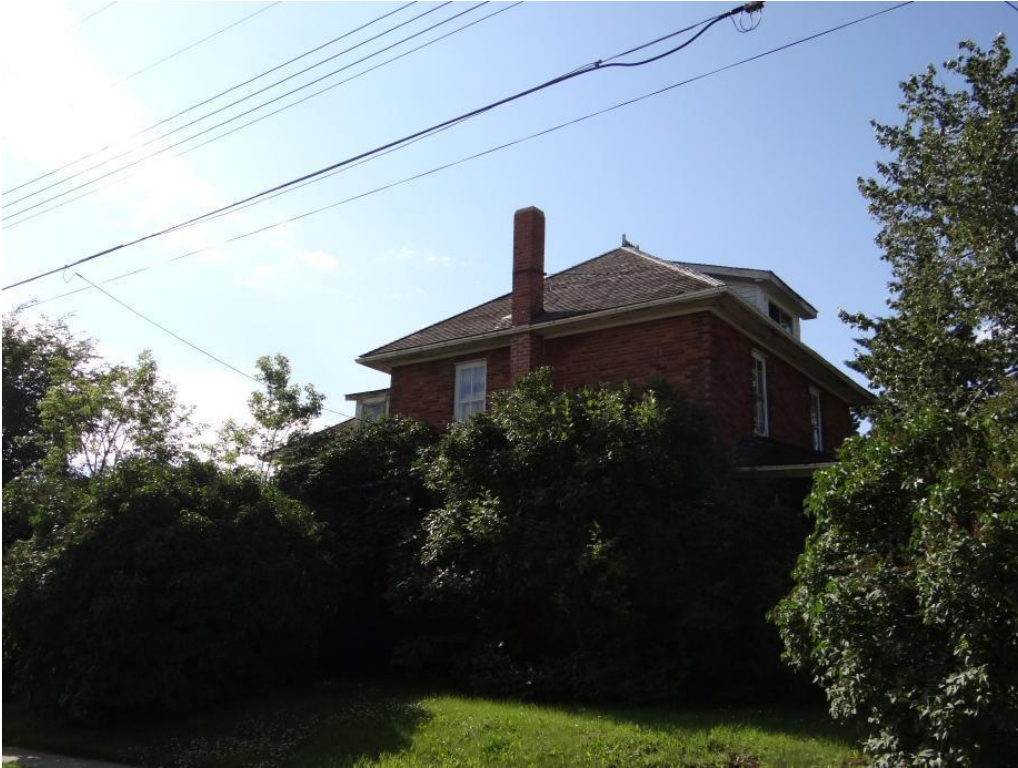
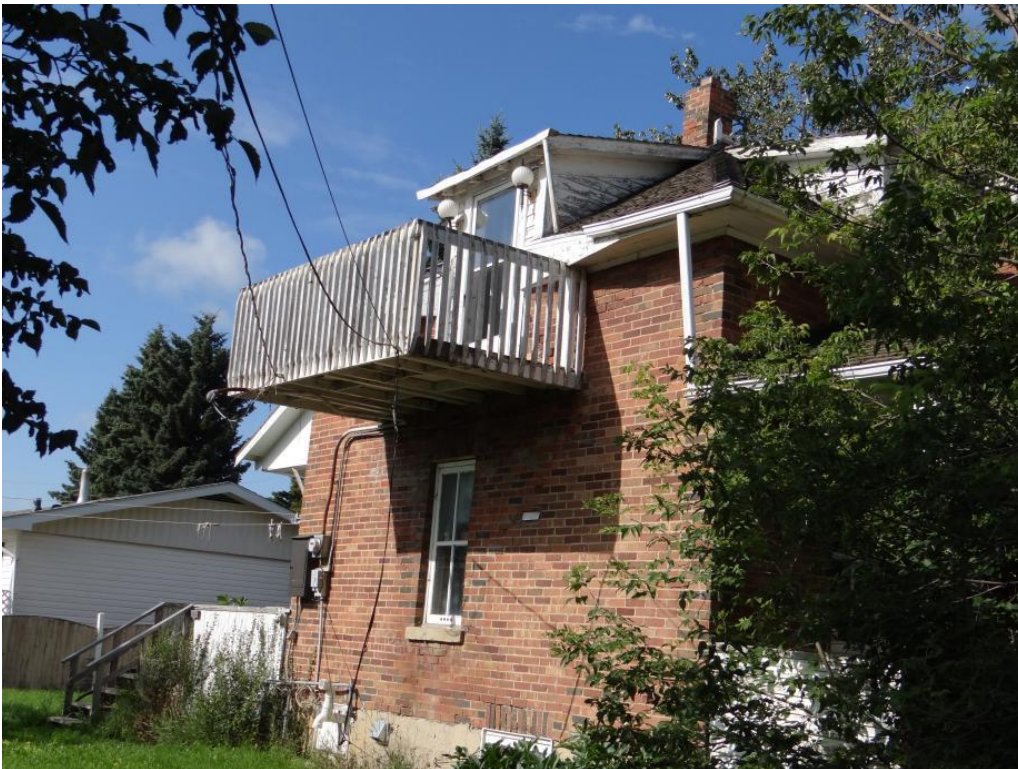
Filename	DSC00944.jpg	View	NW Corner
Date	July 25, 2012	Source	D. Dudzik

Architectural Style	N/A	Plan Shape	1203: Rectangular Short Façade
Storeys	1502: 1 (1701: no Basement)	Foundation	1807: Concrete
Superstructure	3011: Nailed Frame		
Superstructure Cover	2405: Stucco / 2408: Vinyl		
Roof Structure	3202: Medium Gable (3302: Centre Gable)		
Roof Cover	3405: Asphalt Shingle		
Massing	1101: Single Detached	Wings	1314: Irregular
Wall Design and Detail	N/A		
Roof Detail	Chimney – Offset Right/Rear (Brick)		
Windows	5508: Shaped Transom (Blind); shutters		
Main Entrance	6106: Not on Façade		
Main Porch and Stairs	7103: Ground Floor, With Railing; 7208: Angled; 7304: Open Porch (Posts, Wood)		
Exterior	The exterior finish is not original and a number of features have been modified and would bear little resemblance to the original Craftsman-style home.		
Interior	N/A		
Condition	Structure: Good. Upkeep: Good.		
Alterations	Extensive restoration, alterations, and addition of wings carried out c. 1951.

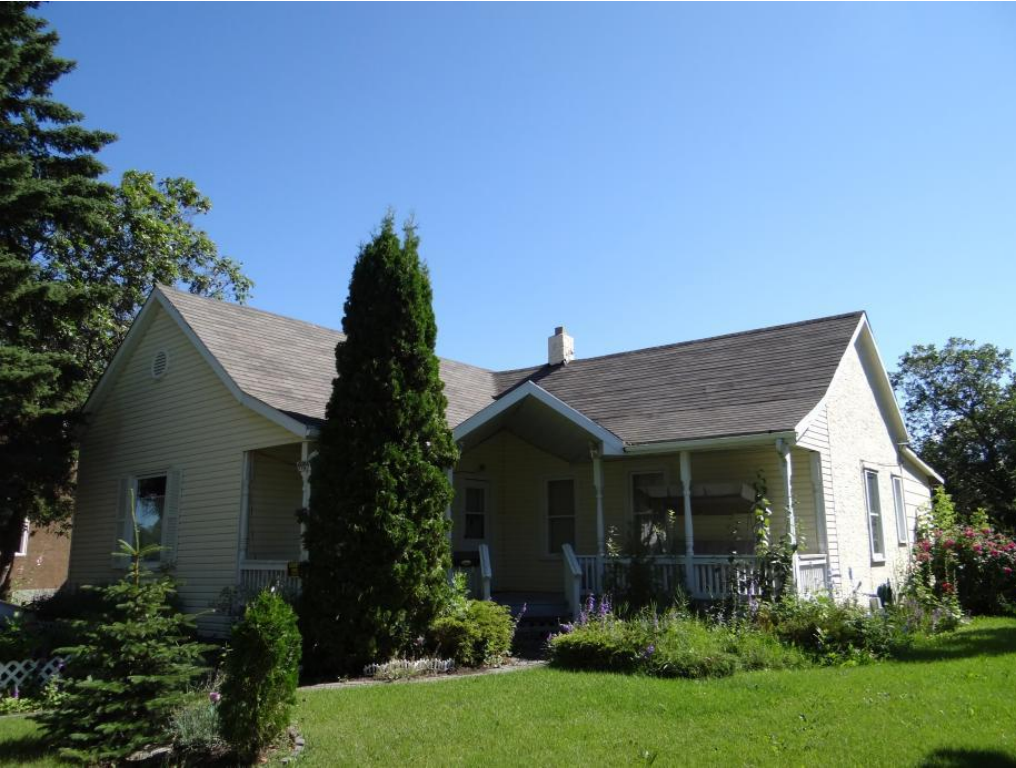
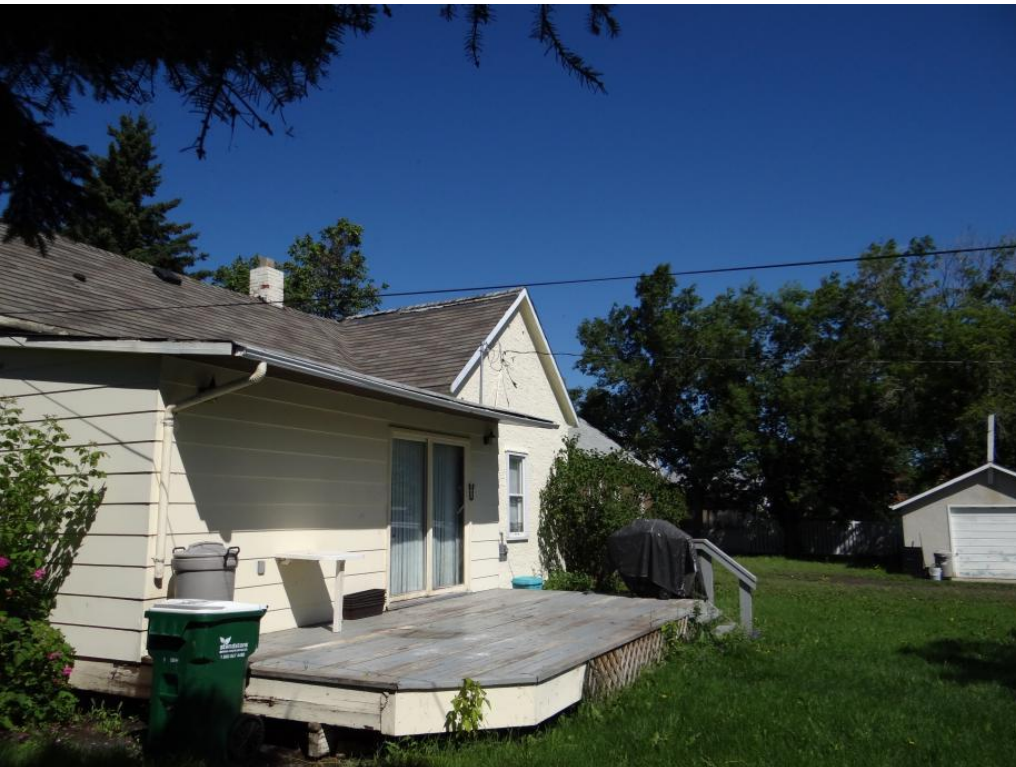
DSC00781.jpg

Architectural Style	N/A	Plan Shape	1203: Rectangular Short Façade
Storeys	1502: 1 (1707: full-above Basement)	Foundation	1807: Concrete
Superstructure	3011: Nailed Frame		
Superstructure Cover	2408: Vinyl		
Roof Structure	3202: Medium Gable		
Roof Cover	3405: Asphalt Shingle		
Massing	1101: Single Detached	Wings	1304: Right Side
Wall Design and Detail	N/A		
Roof Detail	Chimney – Offset Rear; Offset Front/Exterior Left (Brick)		
Windows	5026: Gable Projection		
Main Entrance	6106: Not on Façade		
Main Porch and Stairs	N/A		
Exterior	The form, scale, and massing bear some elements of the Craftsman Style. The exterior finish is not original.		
Interior	N/A		
Condition	Structure: Good. Upkeep: Good.		
Alterations	Addition of wing c. 1951. Exterior refinished.

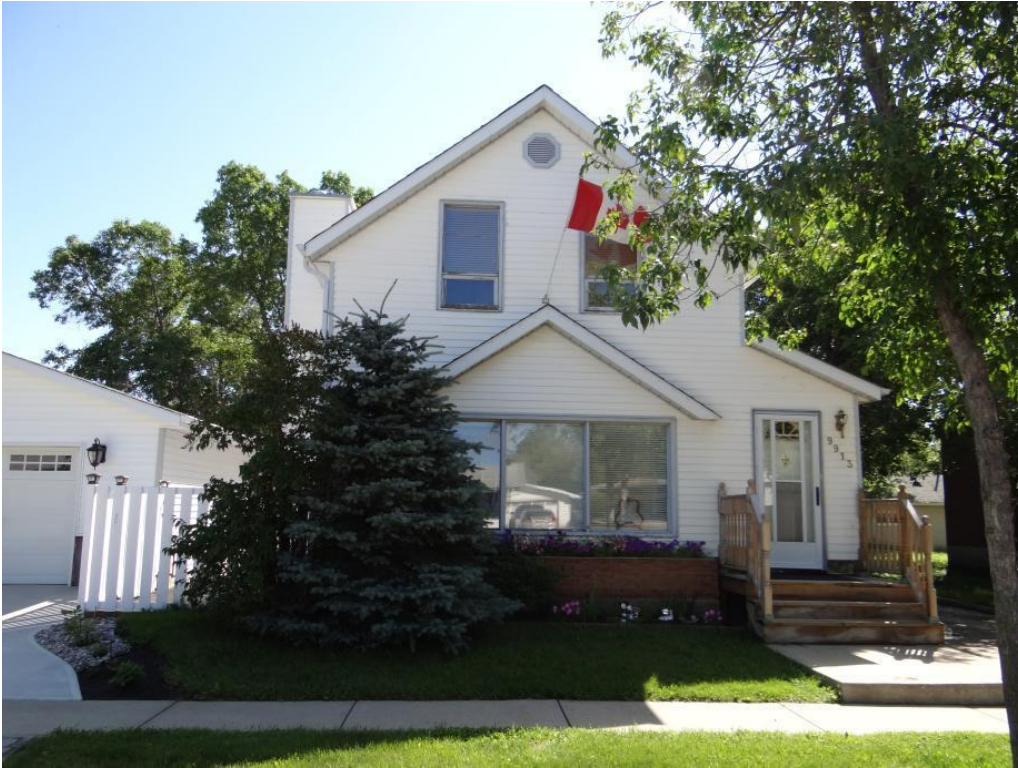
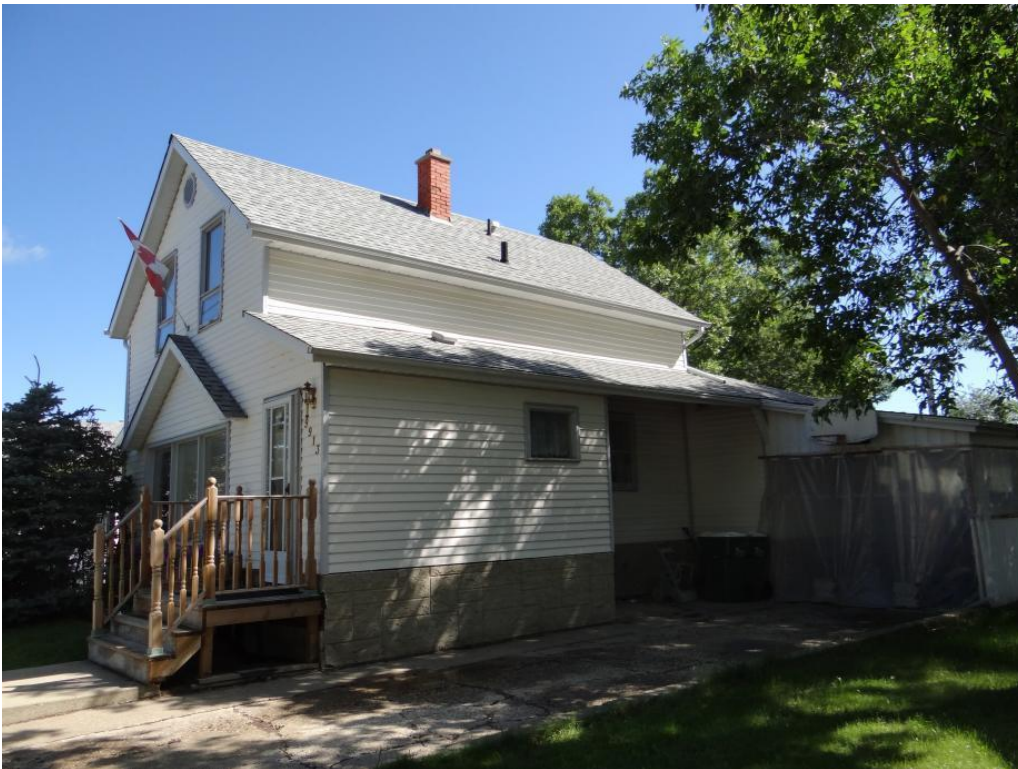
Architectural Style	N/A	Plan Shape	1204: "L"
Storeys	1503: 1½ (1708: full-below Basement)	Foundation	1805: Stone
Superstructure	3011: Nailed Frame		
Superstructure Cover	2405: Stucco / 2408: Vinyl		
Roof Structure	3208: Medium Hip		
Roof Cover	3405: Asphalt Shingle		
Massing	1101: Single Detached	Wings	N/A
Wall Design and Detail	N/A		
Roof Detail	4207: Dormer (Hip); 4211: Dormer (Shed)		
Windows	N/A		
Main Entrance	6102: Centre Façade		
Main Porch and Stairs	7103: Ground Floor, With Railing; 7202: Straight (Wood)		
Exterior	The form, scale, and massing bear some elements of the Prairie Style. The exterior finish is not original.		
Interior	N/A		
Condition	Structure: Fair. Upkeep: Fair. Zoned C-1 District (non-conforming use).		
Alterations	Exterior refinished.

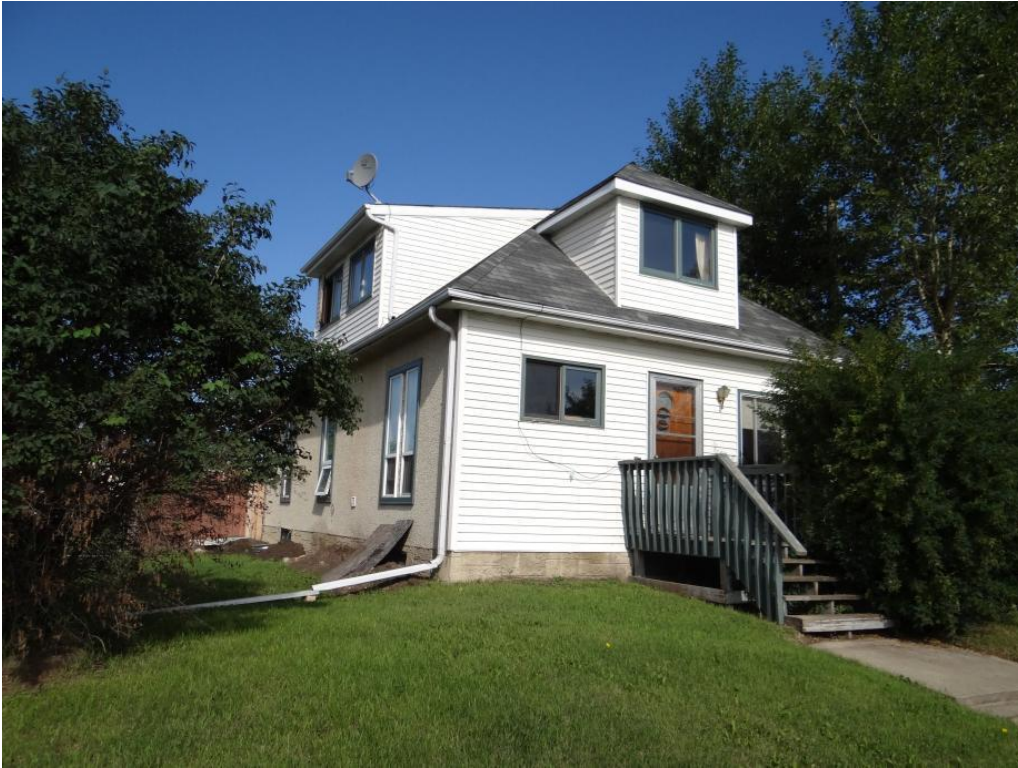
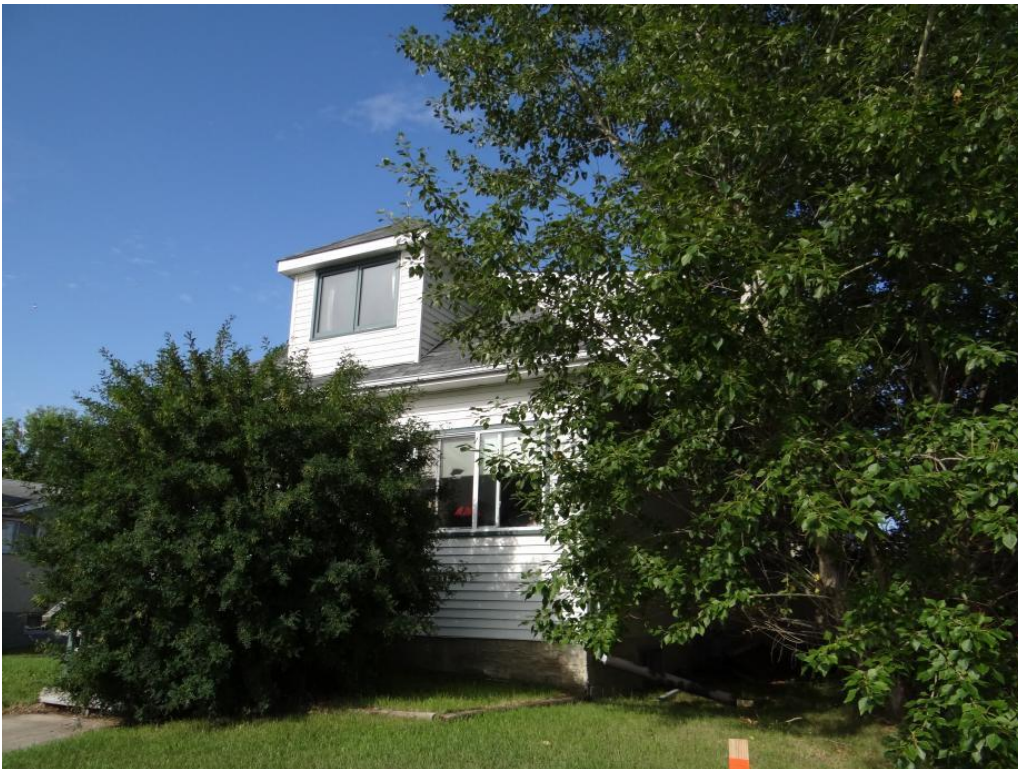
Filename	DSC00722.jpg	View	SE Corner
Date	July 18, 2012	Source	D. Dudzik

Architectural Style	N/A	Plan Shape	1203: Rectangular Short Façade
Storeys	1503: 1½ (1701: no Basement)	Foundation	1807: Concrete
Superstructure	3011: Nailed Frame		
Superstructure Cover	2405: Stucco		
Roof Structure	3202: Medium Gable		
Roof Cover	3405: Asphalt Shingle		
Massing	1101: Single Detached	Wings	1310: Rear and Left
Wall Design and Detail	N/A		
Roof Detail	3503: Projecting Eaves (Wood); 3703: Projecting Verges; Chimney – Centred (Concrete)		
Windows	4902: Flat (Plain Flat Head/Sides/Lug Sill, Wood)		
Main Entrance	6102: Centre Façade (Plain Flat Head/Sides, Wood)		
Main Porch and Stairs	7302: Platform (Open Railing)		
Exterior	The form, scale, and massing bear some elements of the Craftsman Style. The exterior finish is not original. A number of components have been altered.		
Interior	N/A		
Condition	Structure: Fair. Upkeep: Fair.		
Alterations	Addition built c. 1943. Exterior refinished.

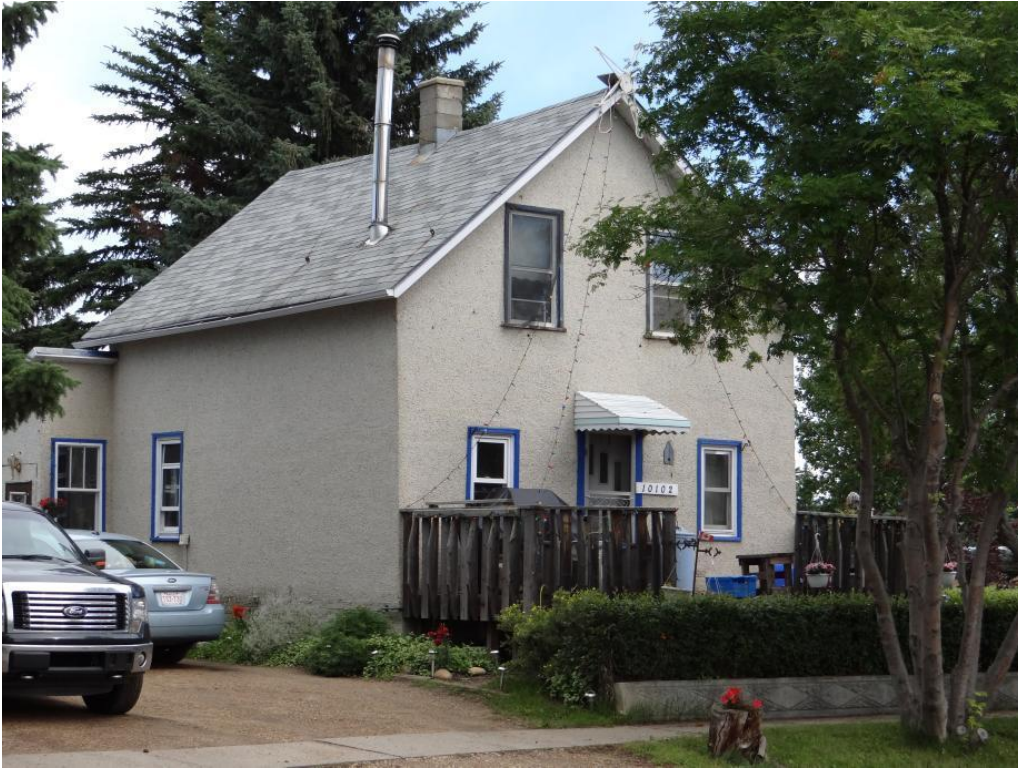
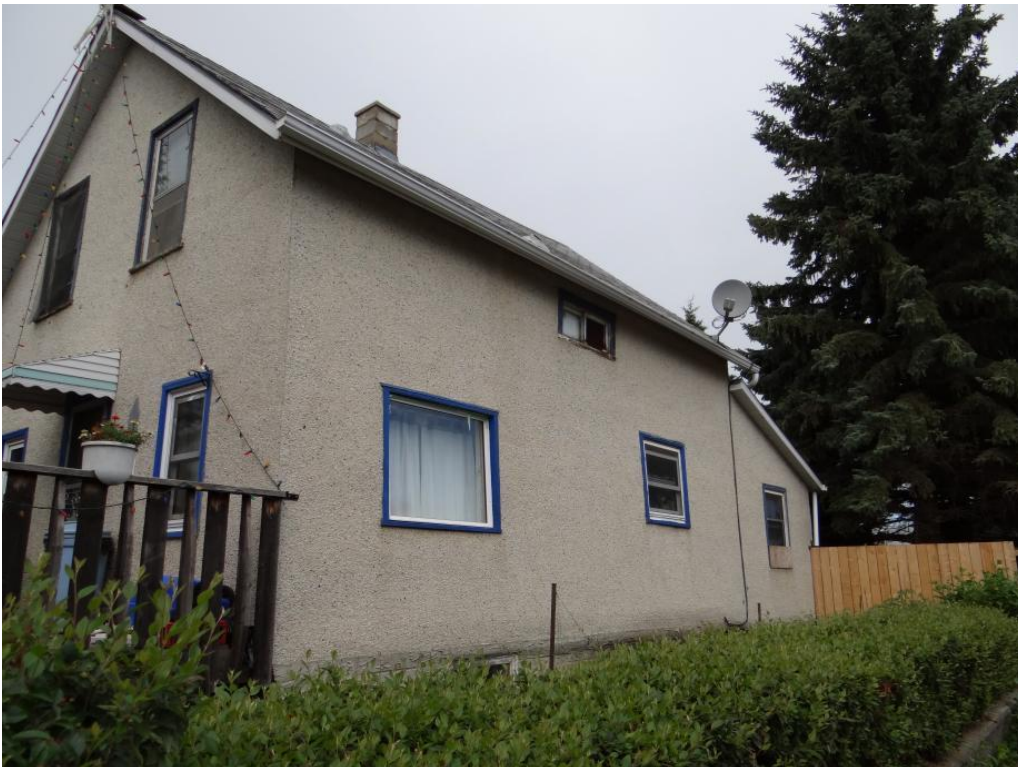
Architectural Style	N/A	Plan Shape	1202: Rectangular Long Façade
Storeys	1503: 1½ (1701: no Basement)	Foundation	1804: Wood
Superstructure	3011: Nailed Frame		
Superstructure Cover	2405: Stucco		
Roof Structure	3202: Medium Gable		
Roof Cover	3405: Asphalt Shingle		
Massing	1101: Single Detached	Wings	1308: Rear
Wall Design and Detail	N/A		
Roof Detail	N/A		
Windows	N/A		
Main Entrance	6106: Not on Façade		
Main Porch and Stairs	7103: Ground Floor, With Railing; 7203: Straight Side; 7304: Open Porch (Wood)		
Exterior	The form, scale, and massing bear some elements of the Craftsman Style. The exterior finish is not original. The building overall is in need of refurbishing. Of particular note is the foundation bulging in the rear.		
Interior	N/A		
Condition	Structure: Poor. Upkeep: Fair.		
Alterations	Extensive alterations and addition of wings carried out c. 1950.

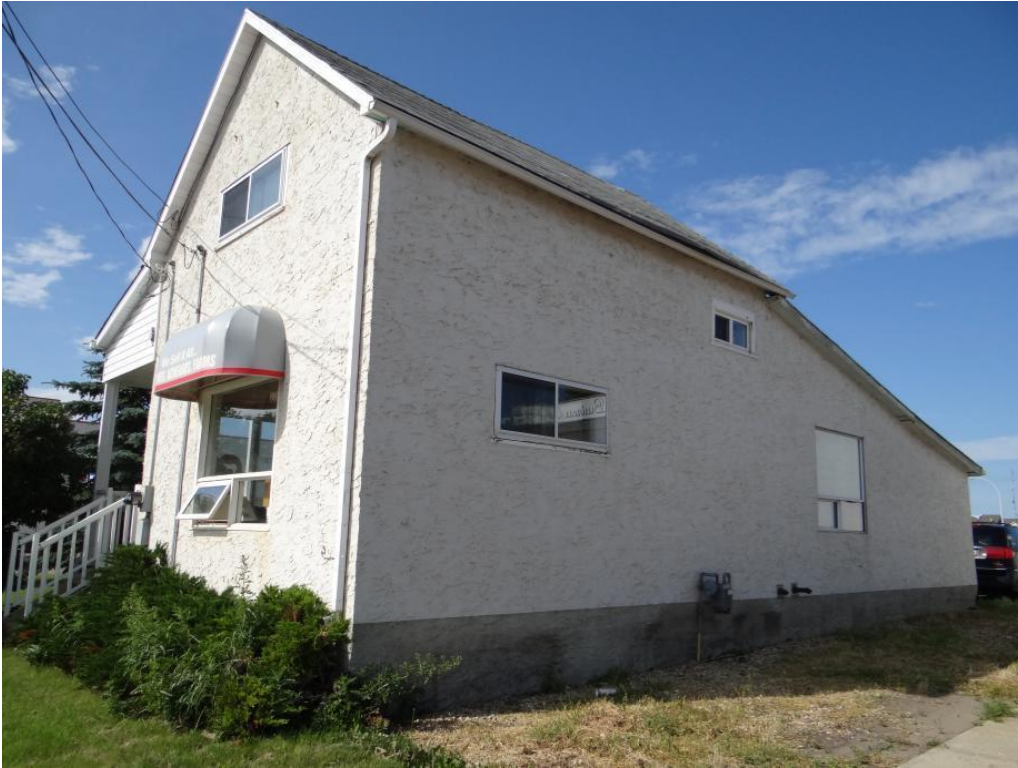
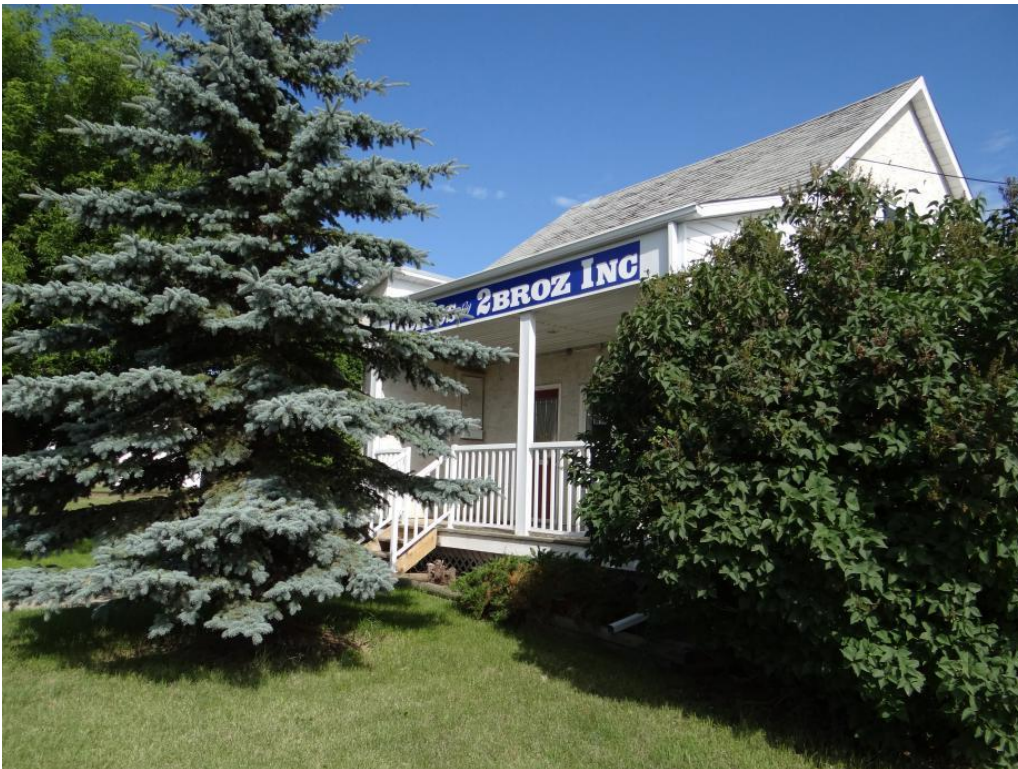
Filename	DSC00733.jpg	View	NE Corner
Date	July 18, 2012	Source	D. Dudzik

Architectural Style	N/A	Plan Shape	1204: "L"
Storeys	1504: 2 (1701: no Basement)	Foundation	1804: Wood
Superstructure	3011: Nailed Frame		
Superstructure Cover	2408: Vinyl		
Roof Structure	3202: Medium Gable		
Roof Cover	3405: Asphalt Shingle		
Massing	1101: Single Detached	Wings	1308: Rear
Wall Design and Detail	N/A		
Roof Detail	3716: Returned Eaves		
Windows	4902: Flat (Flat Transom (Blind), One Fixed Sash, 2 over 2)		
Main Entrance	6102: Centre Façade		
Main Porch and Stairs	N/A		
Exterior	The form, scale, and massing bear some elements of the Craftsman Style. The exterior finish is not original.		
Interior	N/A		
Condition	Structure: Fair. Upkeep: Good.		
Alterations	Extensive alterations and additions c. 1942 which are complementary to the original building.

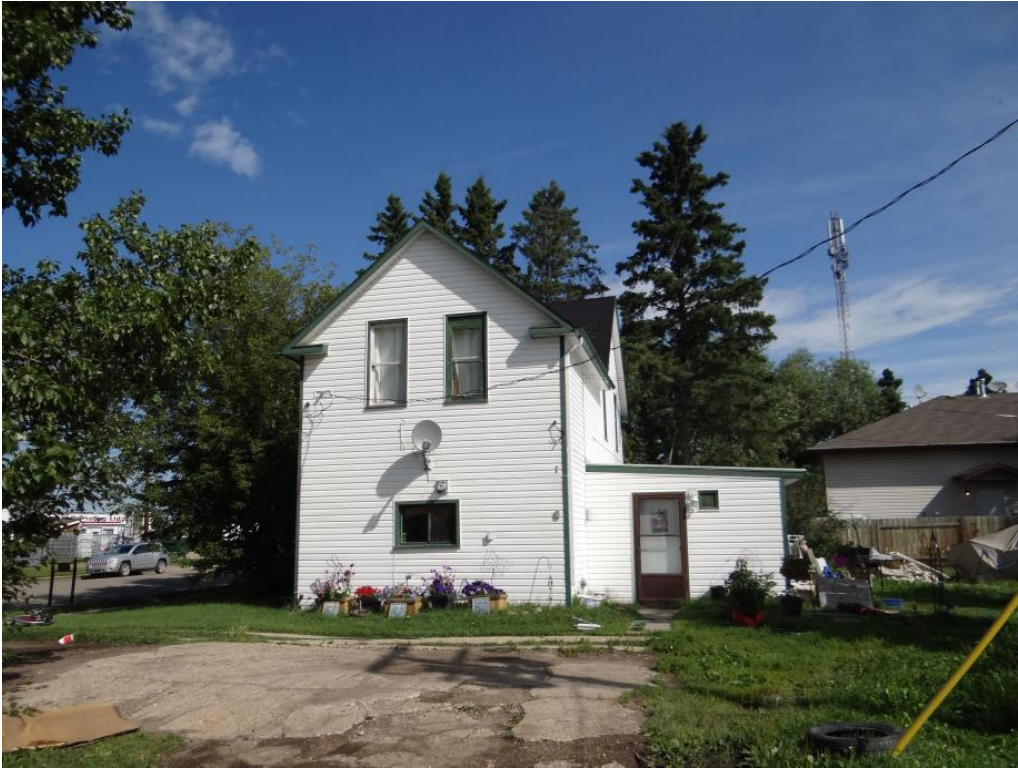
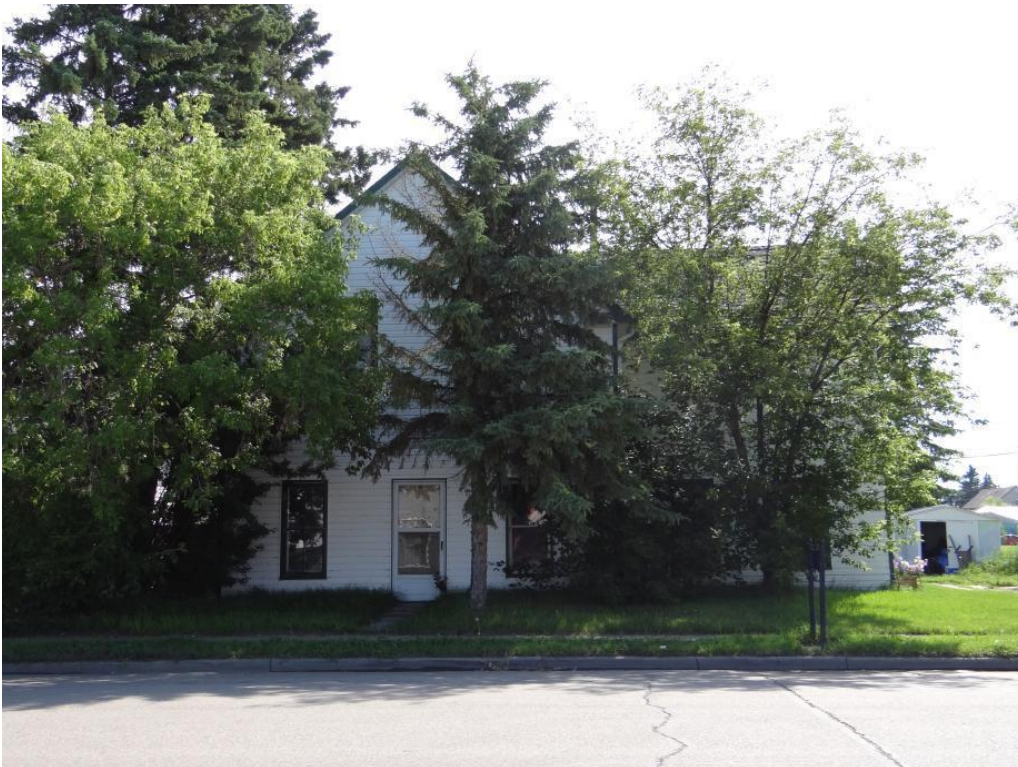
Filename	DSC00738.jpg	View	South Side
Date	July 18, 2012	Source	D. Dudzik

Architectural Style	N/A	Plan Shape	1202: Rectangular Long Façade
Storeys	1503: 1½ (1701: no Basement)	Foundation	1804: Wood
Superstructure	3011: Nailed Frame		
Superstructure Cover	2408: Vinyl		
Roof Structure	3202: Medium Gable		
Roof Cover	3405: Asphalt Shingle		
Massing	1101: Single Detached	Wings	1308: Rear
Wall Design and Detail	N/A		
Roof Detail	Chimney – Centre/Rear (Brick)		
Windows	4902: Flat (Plain Flat Head/Sides/Slip Sill, Wood)		
Main Entrance	6102: Centre Façade		
Main Porch and Stairs	7304: Open Porch (Posts, Open Railing, Wood)		
Exterior	The exterior finish is not original. The building overall is in good shape.		
Interior	N/A		
Condition	Structure: Good. Upkeep: Good.		
Alterations	Addition built c. 1951. Exterior refinished.

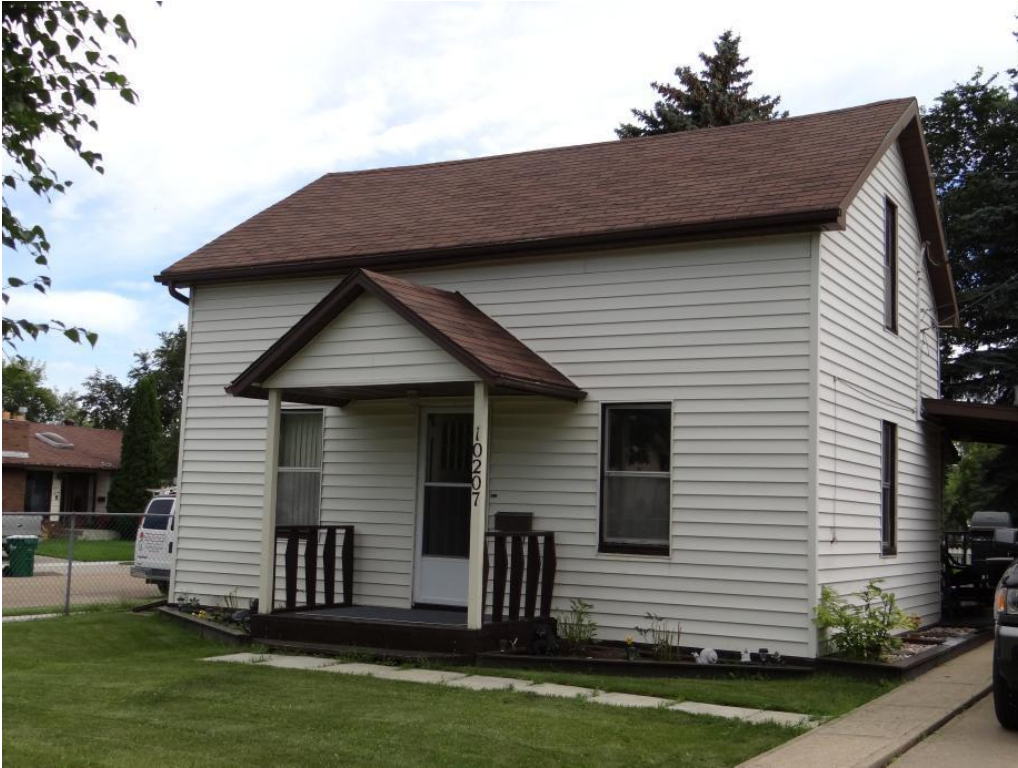
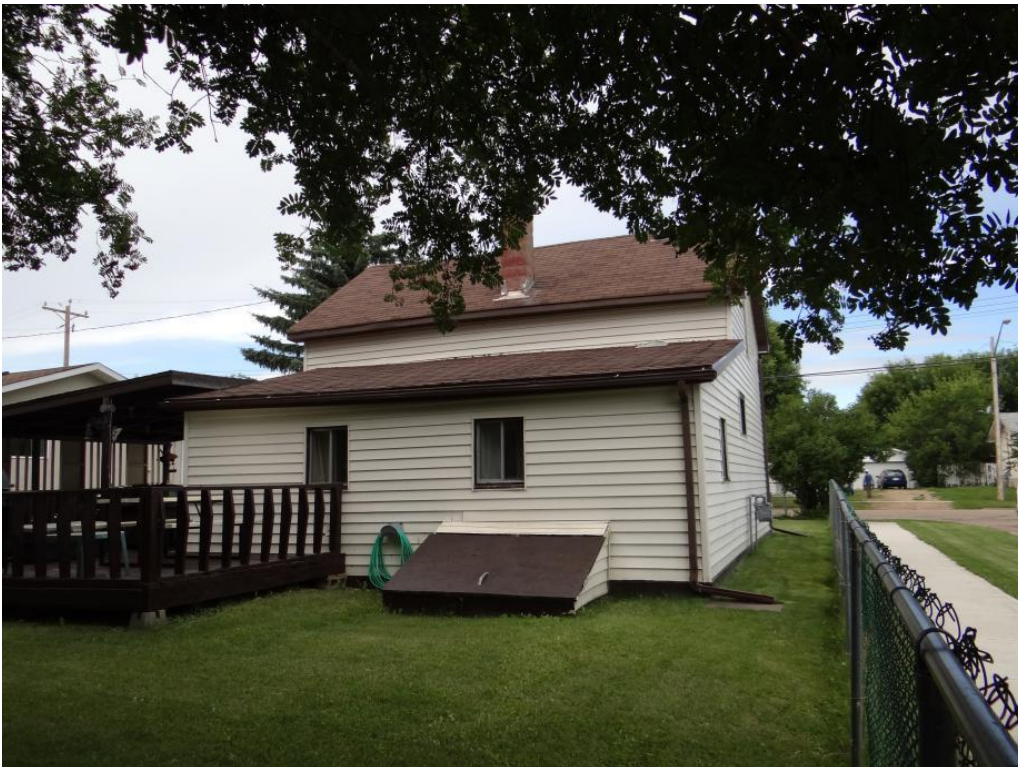
Filename	DSC00935.jpg	View	SW Corner
Date	July 24, 2012	Source	D. Dudzik

Architectural Style	9031: Four-square	Plan Shape	1201: Square
Storeys	1504: 2 (1707: full-above Basement)	Foundation	1807: Concrete
Superstructure	3011: Nailed Frame		
Superstructure Cover	2014: Wood (Clapboard) / 2405: Stucco		
Roof Structure	3208: Medium Hip		
Roof Cover	3405: Asphalt Shingle		
Massing	1101: Single Detached	Wings	1308: Rear
Wall Design and Detail	N/A		
Roof Detail	3512: Moulded Frieze (Wood); Chimney – Exterior Left/Offset Rear & Offset Right (Concrete)		
Windows	4902: Flat (Moulded Lintel); 5113: Shutters (Wood)		
Main Entrance	6102: Centre Façade (Moulded Lintel)		
Main Porch and Stairs	7104: Ground Floor, Closed Railing; 7203: Straight Side; 7306: Open Verandah (Columns, Decorated, Wood)		
Exterior	The form, scale, and massing reflect the Four-square style with a number of architectural details and elements. The side portico, balcony, upper level windows, shutters, and exterior finish are not original. The building overall is in good shape.

Interior	High ceilings, 9" baseboards on first floor, and a wide staircase to upper level.		
Condition	Structure: Good. Upkeep: Good.		
Alterations	Extensive renovations undertaken c. 1975.
