# Morinville Heritage Survey

FINAL REPORT | May 2013

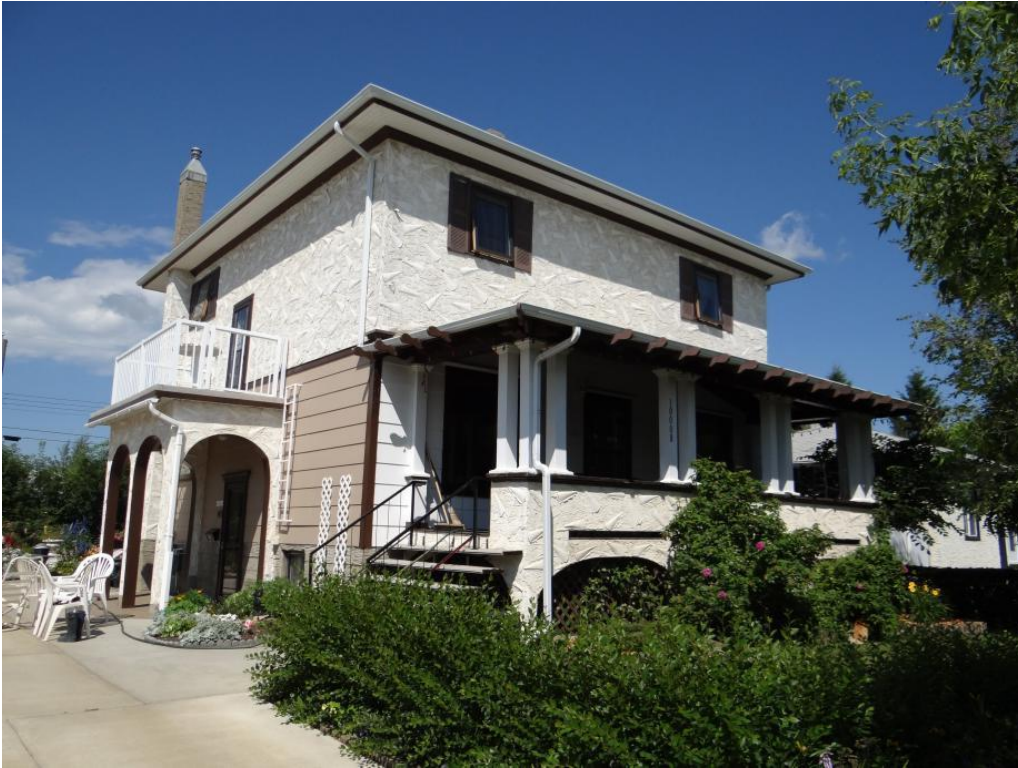
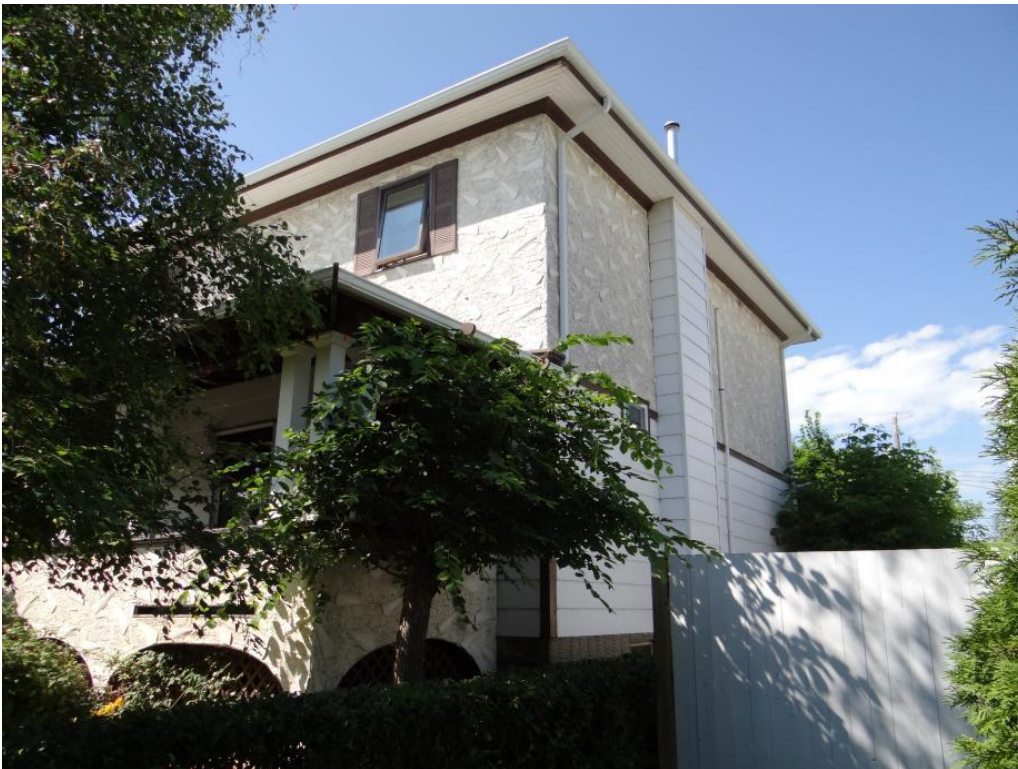
DSC00767.jpg

Architectural Style	N/A	Plan Shape	1203: Rectangular Short Façade
Storeys	1502: 1 (1708: full-above Basement)	Foundation	1807: Concrete
Superstructure	3011: Nailed Frame		
Superstructure Cover	2405: Stucco		
Roof Structure	3202: Medium Gable		
Roof Cover	3405: Asphalt Shingle		
Massing	1101: Single Detached	Wings	1304: Right
Wall Design and Detail	N/A		
Roof Detail	3512: Moulded Frieze (stucco); 3703: Projecting Verges (Wood)		
Windows	4902: Flat (Plain Slip Sill, Wood)		
Main Entrance	6103: Off-Centre Façade (Moulded Flat, Decorated Lintel/Sides, Stone, Side Light)		
Main Porch and Stairs	7102: Ground Floor, No Railing; 7202: Straight; 7302: Platform (Open Railing, Wood)		
Exterior	The exterior finish is not original and a number of features have been modified and would bear little resemblance to the original home.		
Interior	N/A		
Condition	Structure: Poor. Upkeep: Poor.		
Alterations	Addition of wing c. 1945. Exterior refinished.

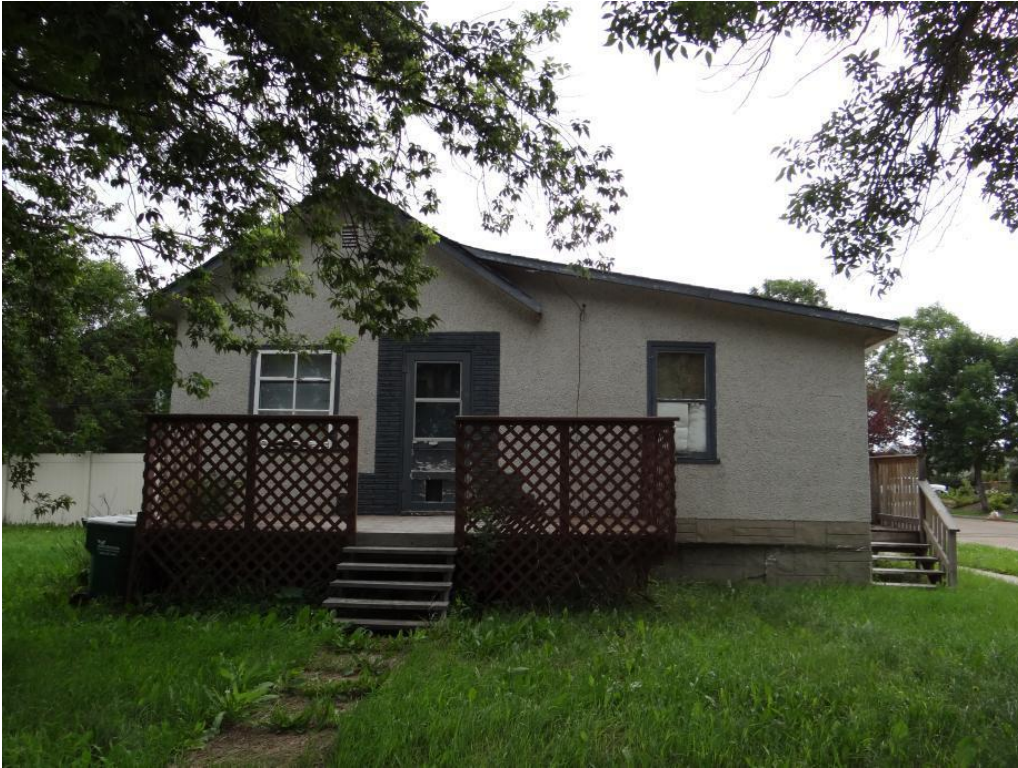
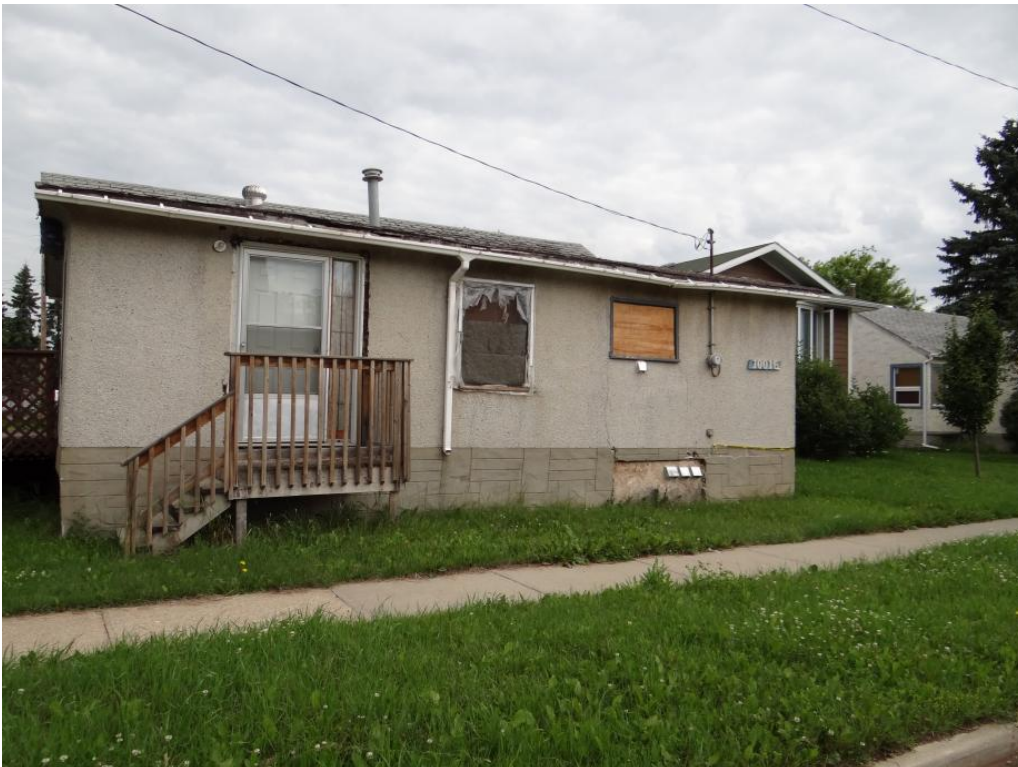
Filename	DSC00977.jpg	View	West Side
Date	July 25, 2012	Source	D. Dudzik

Architectural Style	N/A	Plan Shape	1206: "T"
Storeys	1503: 1½ (1707: full-above Basement)	Foundation	1807: Concrete
Superstructure	3011: Nailed Frame		
Superstructure Cover	2011: Wood (Shiplap)		
Roof Structure	3202: Medium Gable		
Roof Cover	3405: Asphalt Shingle		
Massing	1101: Single Detached	Wings	1304: Left Side
Wall Design and Detail	3122: Plain Parapet		
Roof Detail	3503: Projecting Eaves/Verges (Wood); 3512: Moulded Friezes		
Windows	4902: Flat (Plain Flat Head/Sides, Plain Slip Sill, Wood)		
Main Entrance	6106: Not on Façade (Plain, Wood, Shaped Panel)		
Main Porch and Stairs	7103: Ground Floor, With Railing; 7203: Straight Side; 7306: Open Verandah (Posts, Open Railing, Decorated, Pediment, Wood)		
Exterior	The form, scale, and massing bear some elements of the Craftsman Style.		
Interior	N/A		
Condition	Structure: Good. Upkeep: Good.		
Alterations	Extensive alterations and additions c. 1950 which are complementary to the original building.
