Champagne District Area Structure Plan

Bylaw 9/2006

Lovatt Planning Consultants Inc.

March 2006

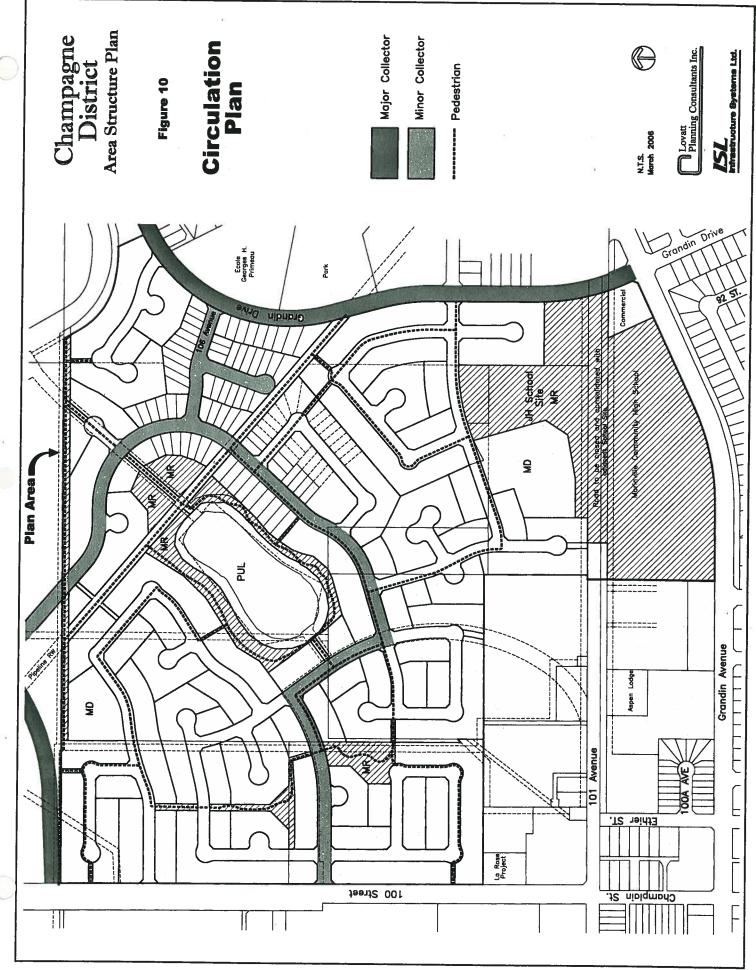
A pedestrian trail system will follow the Pembina pipeline right of way in the northeast quadrant of the area. Construction of this trail system will be dependent on the necessary permits from the oil company for construction within their right of way. This trail will link with a series of roads and public utility lots to form a comprehensive pedestrian network (see Figure 10).

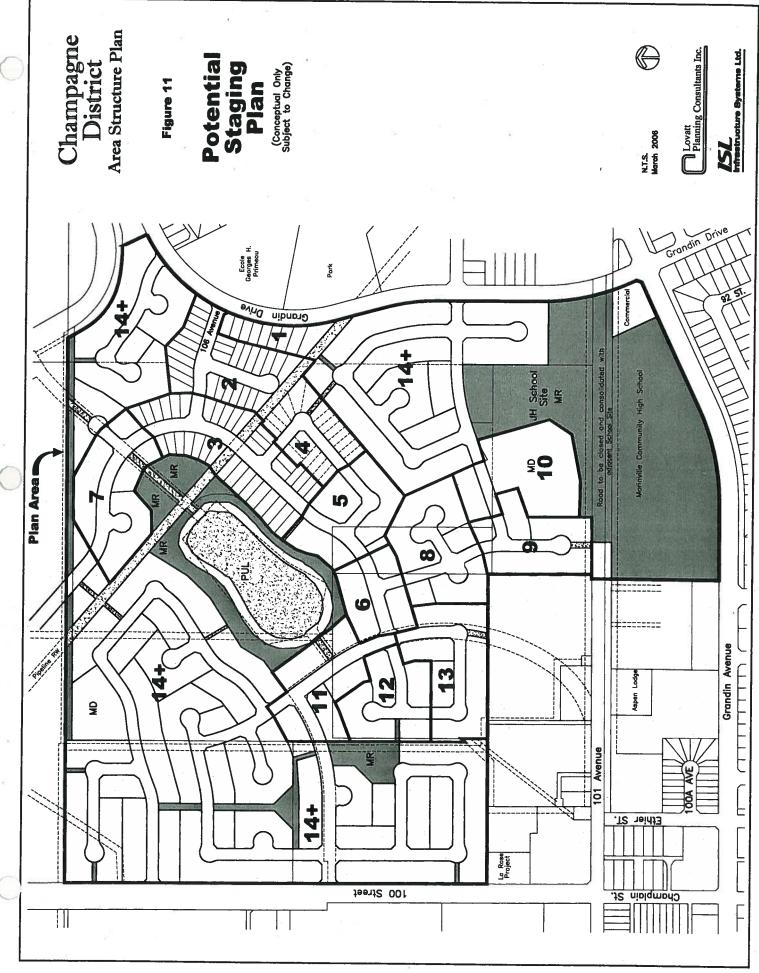
A Potential Staging Plan is shown on Figure 11. The first three phases are developed as Stages 1 to 3B. Stages 4 and 5 are imminent, and future stages are dependent on approval of this Area Structure Plan. Watermain looping and a temporary road will be required to allow the development of Stages 4 and 5.
