CHAMPAGNE DISTRICT

Area Structure Plan

Lovatt
Planning Consultants Inc.

ISL Infrastructure Systems Ltd.

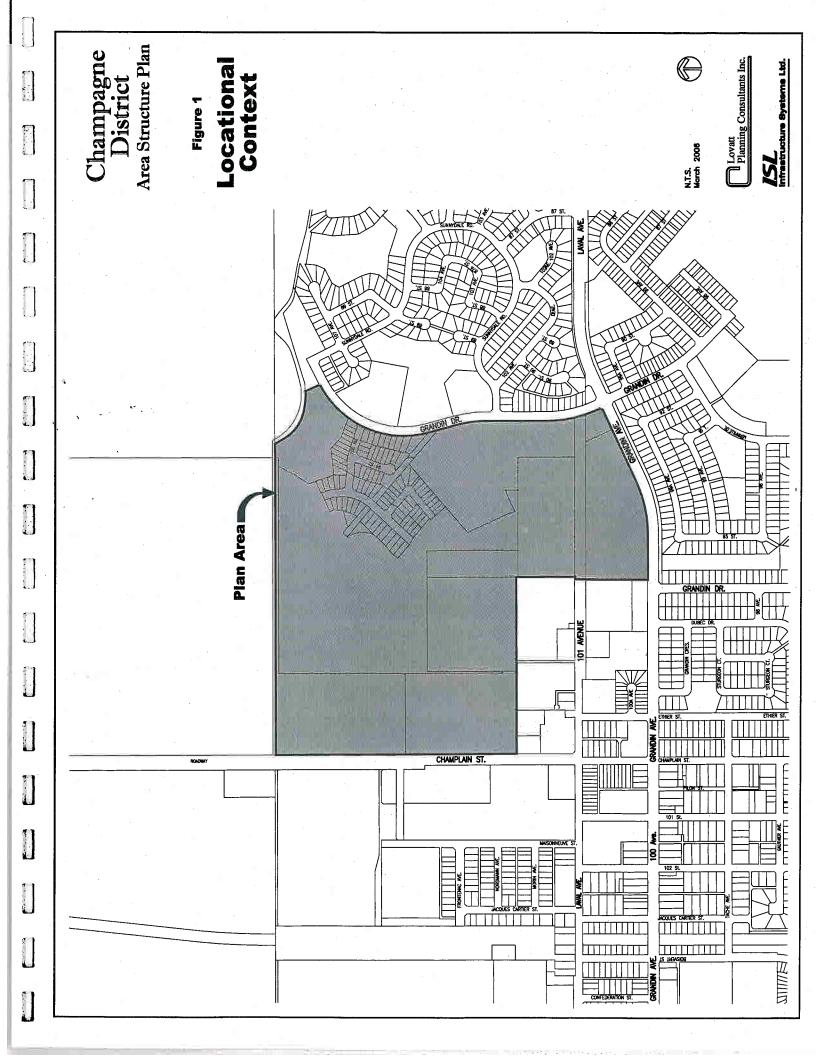
Figure 1 shows the boundaries of the Plan area, and its location within the Town.

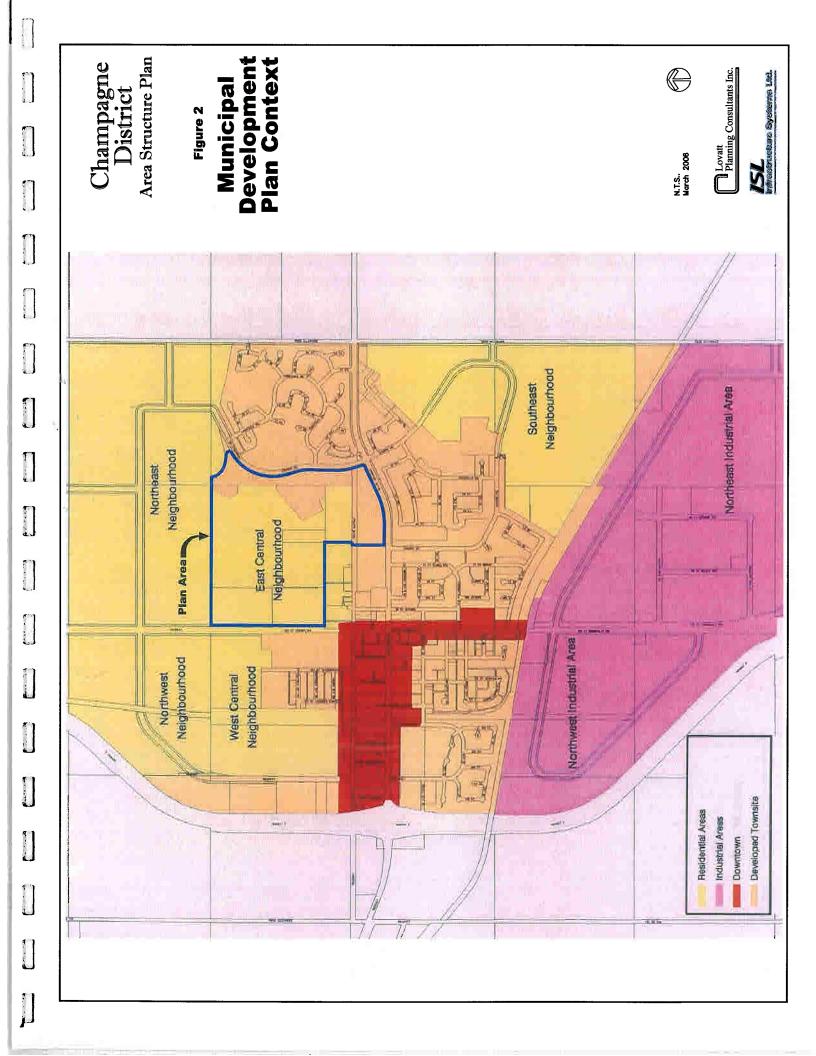
The Champagne District Area Structure Plan complies with the Town of Morinville's Municipal Development Plan Bylaw No. 19/98 (see Figure 2) in terms of generalized future land use. The Champagne District Plan area is referred to as the East Central Neighbourhood (Residential Area) by the Municipal Development Plan, and although a portion of the lands located just west of Grandin Drive are shown as Developed Townsite, only a portion of these lands have recently been developed by Landrex for single detached housing purposes.

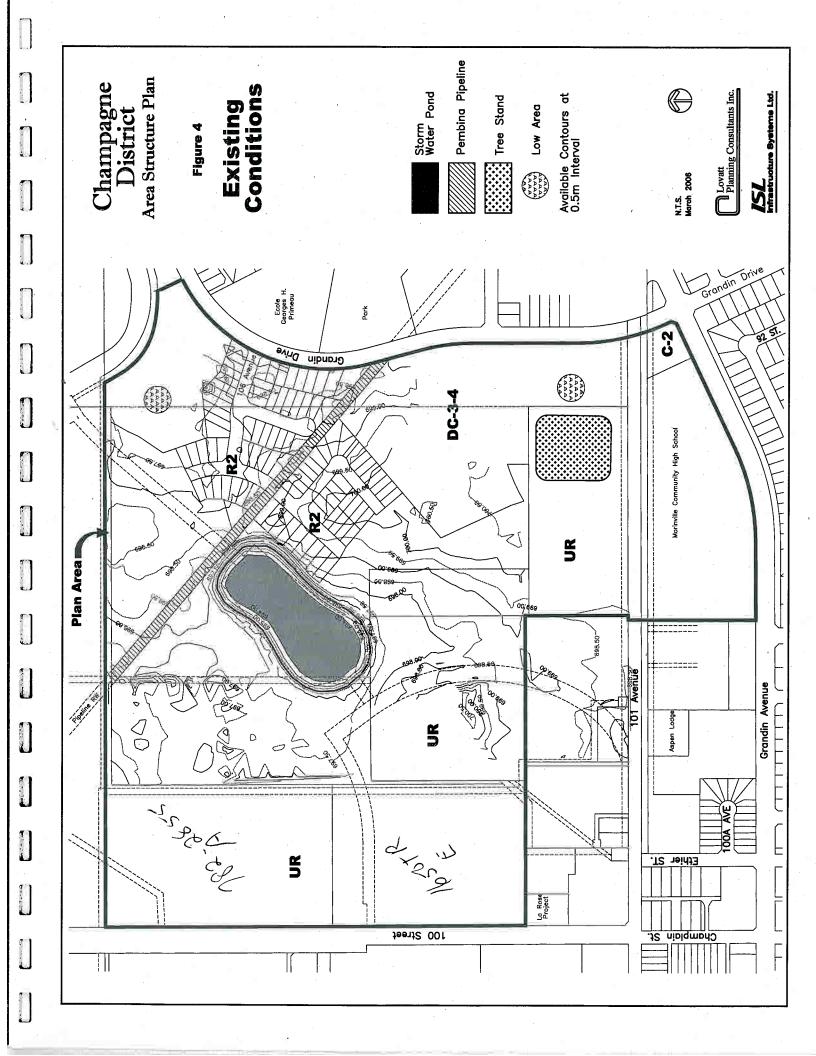
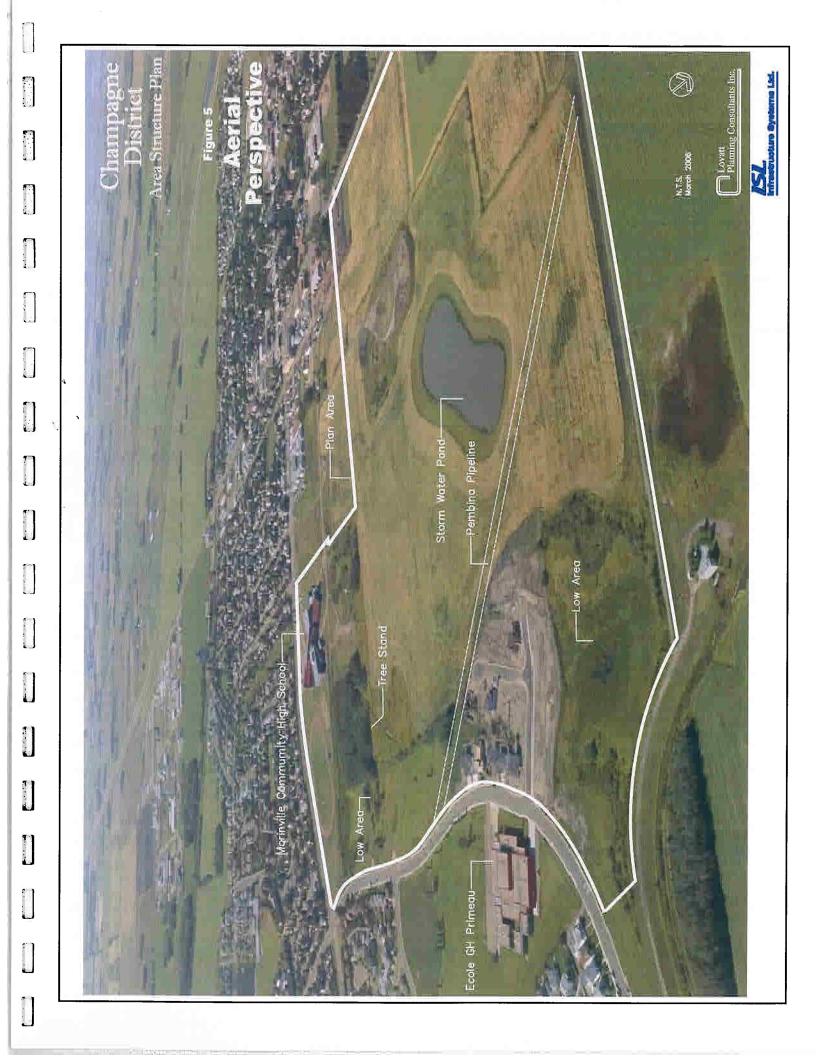
A poplar tree stand is located north of the Community High School. The stand is sparse and contains few mature trees. Other vegetation is limited to a *windrow* and some willows that surround low areas located in the southeast and northeast corners. The low areas are mostly located on the Qualico lands (see Figures 4 and 5). Neither low area contains water permanently.

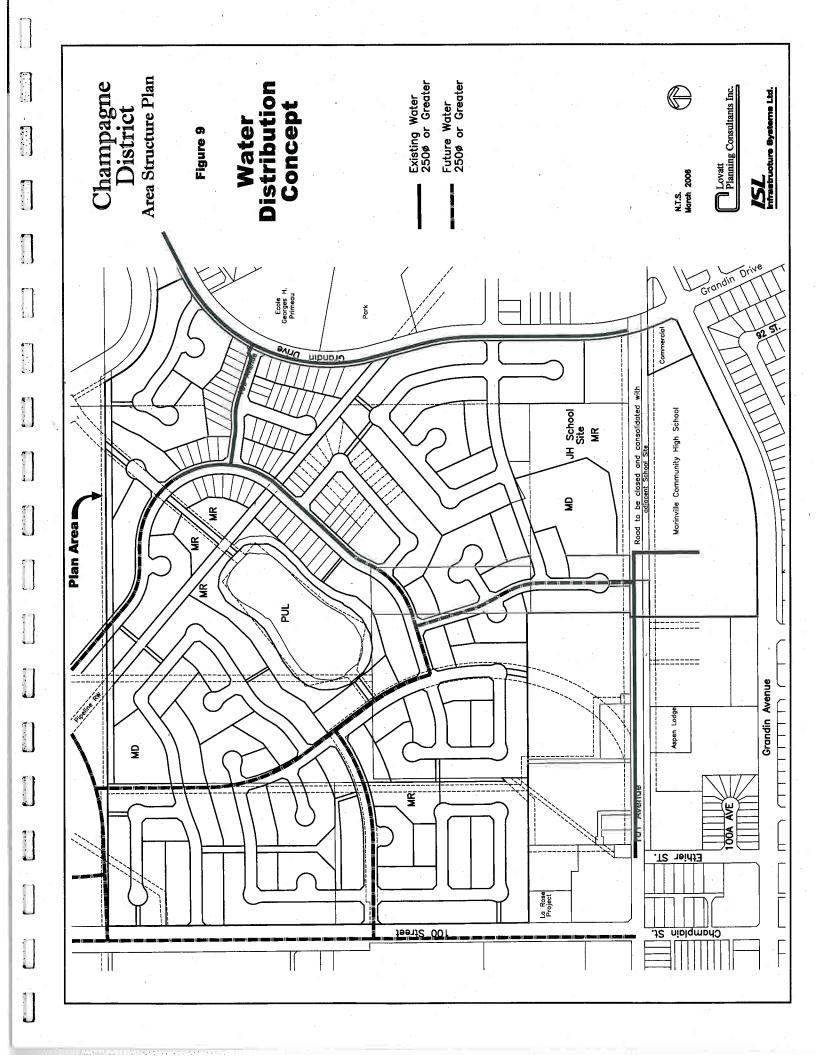
Water service to this Plan will be provided by a looped system sized to provide acceptable domestic flows, with fire flows that achieve recognized standards for residential development (see Figure 9). Water supply is currently provided from a connection to Grandin Drive at 106th Avenue. As development approaches 80 lots, looping will be required by a connection to the existing 250mm main on 101st Avenue. Cost sharing will be required for any capacity in loop system that is required to service the parcel located directly west of the Plan.

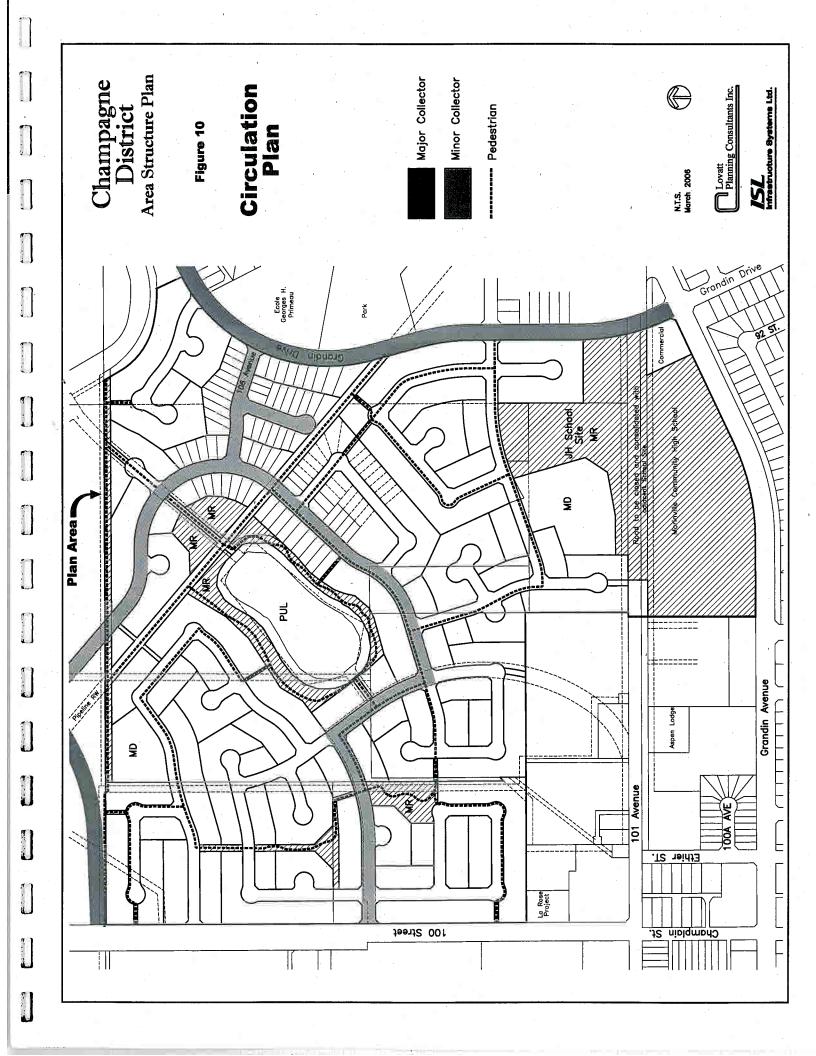
A pedestrian trail system will follow the Pembina pipeline right of way in the northeast quadrant of the area. Construction of this trail system will be dependent on the necessary permits from the oil company for construction within their right of way. This trail will link with a series of roads and public utility lots to form a comprehensive pedestrian network (see Figure 10).

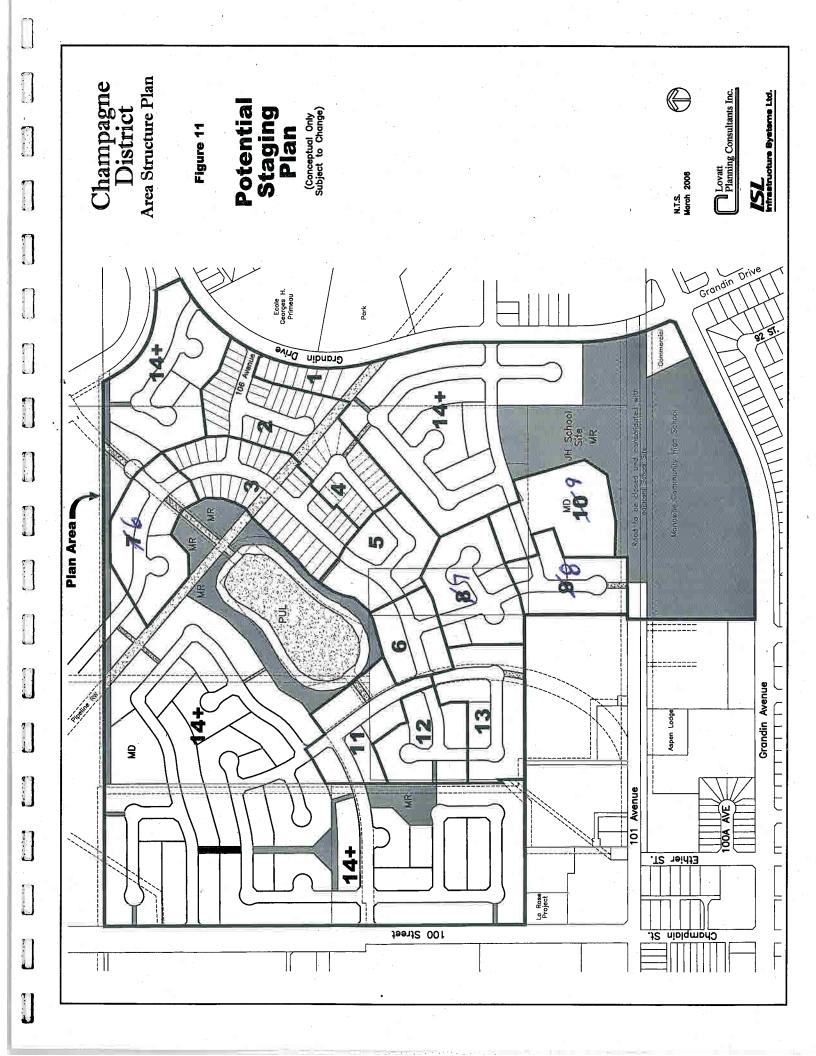
A Potential Staging Plan is shown on Figure 11. The first three phases are developed as Stages 1 to 3B. Stages 4 and 5 are imminent, and future stages are dependent on approval of this Area Structure Plan. Watermain looping and a temporary road will be required to allow the development of Stages 4 and 5.

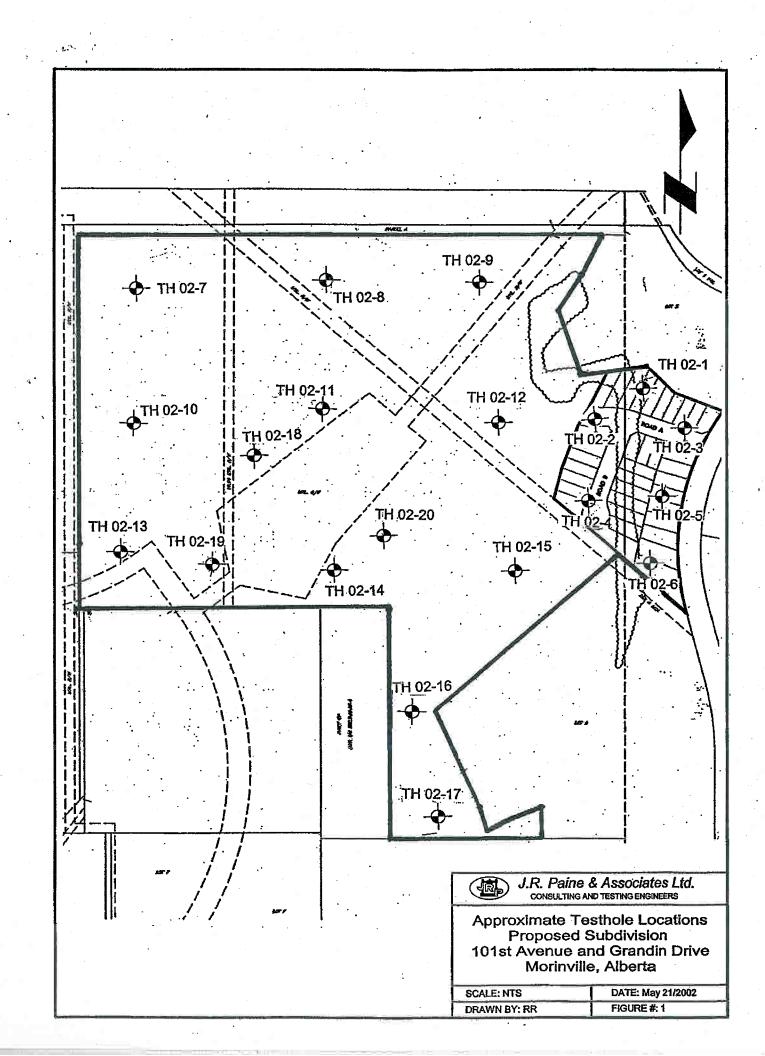
PROJECT: Proposed Subdivision CLIENT: Landrex Developments c/o ISL TEST HOLE NO: 02-1 LOCATION: NW of 101 Ave. and Grandin Dr. DRILL METHOD: Solid Stem Auger PROJECT NO: 2461-170 Morinville, Alberta PROJECT ENGINEER: RR ELEVATION: 697.31 (m) **⊠** SPT SAMPLE TYPE Disturbed Shelby Tube Bulk BACKFILL TYPE BENTONITE PEA GRAVEL SLOUGH GROUT DRILL CUTTINGS ∭ SAND SYMBOL DEPTH(m) SOIL ▲ Packet Pen. (kPa) ▲ 100 200 300 400 TEST SS DESCRIPTION SOL PLASTIC M.C. LIQUID RESULTS 0.0 TOPSOIL and ORGANIC CLAY 275 mm OR CLAY, silty, high plastic, stiff, moist, Ī -below 0.6 m: grey and brown -below 0.8 m: firm to stiff, moist to 1.0 CH very moist 696.0 1.7 m CLAY TILL, silty, sandy, medium plastic, stiff, moist to very moist, brown, trace 2.0 coal, pebbles, oxides -695.0 3,0 3.8 m END OF TESTHOLE 4.0 No accumulation of free water or slough -693.0 material in testhole at completion of drilling. Standpipe installed. 4.5 hr watertable reading: dry 9 day watertable reading: 0.77 m bas 5.0 14 day watertable reading: 0.82 m bgs -692,0 6.0 -691.D - 7.0 -690.0 8.0 -689.0 9.0 COMPLETION DEPTH: 3.8 m LOGGED BY: RR J.R. Paine & Associates COMPLETE: 02/05/21 REVIEWED BY: RE Edmonton, Alberta Fig. No: 2 Page 1 of 1 02/08/27 10:32AM (ELEVO)(P)

A detailed description of the soils encountered is found on the attached testhole logs in the Appendix. In general, the soil conditions at this site consisted of surficial topsoil and occasional clay fill material, underlain by a native silty clay materials. A deposit of clay till featuring various silt and sand layers was the final soil encountered in the testholes.
