# **Champagne District Area Structure Plan**

Bylaw 9/2006

#### **Area Structure Plan**

ISL Infrastructure Systems Ltd.

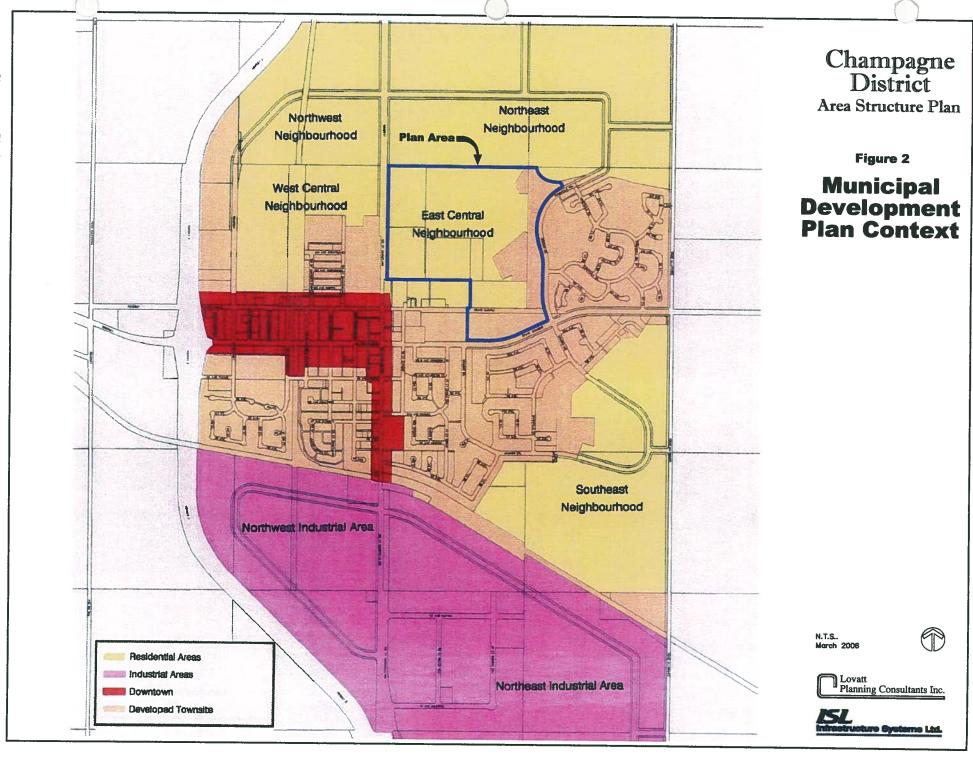
The Champagne District Area Structure Plan complies with the Town of Morinville's Municipal Development Plan Bylaw No. 19/98 (see Figure 2) in terms of generalized future land use. The Champagne District Plan area is referred to as the East Central Neighbourhood (Residential Area) by the Municipal Development Plan, and although a portion of the lands located just west of Grandin Drive are shown as Developed Townsite, only a portion of these lands have recently been developed by Landrex for single detached housing purposes.

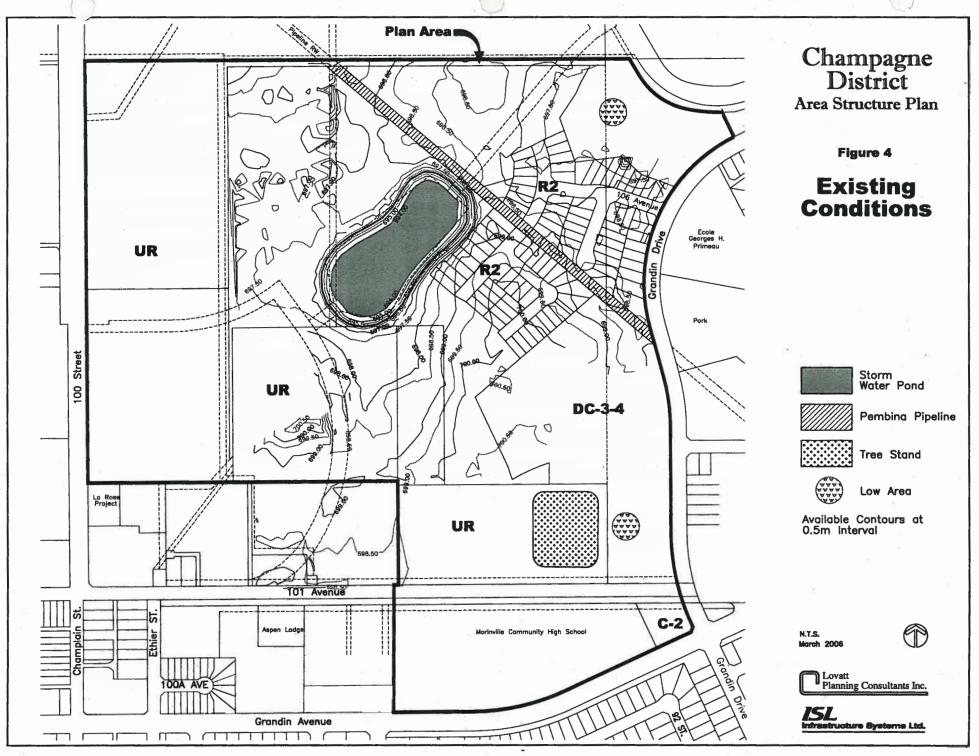
A poplar tree stand is located north of the Community High School. The stand is sparse and contains few mature trees. Other vegetation is limited to a *windrow* and some willows that surround low areas located in the southeast and northeast corners. The low areas are mostly located on the Qualico lands (see Figures 4 and 5). Neither low area contains water permanently.

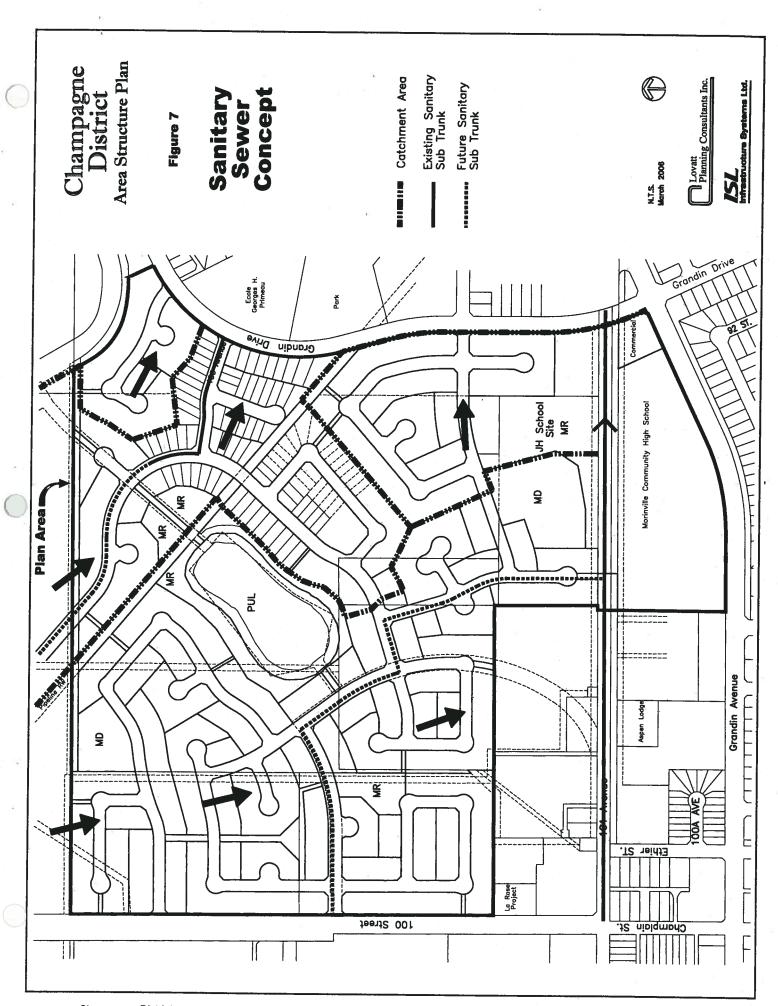
It should be noted that with existing sanitary sewers, changes to land use or design criteria may impact the ability of those sewers to accommodate the catchments shown on Figure 7.

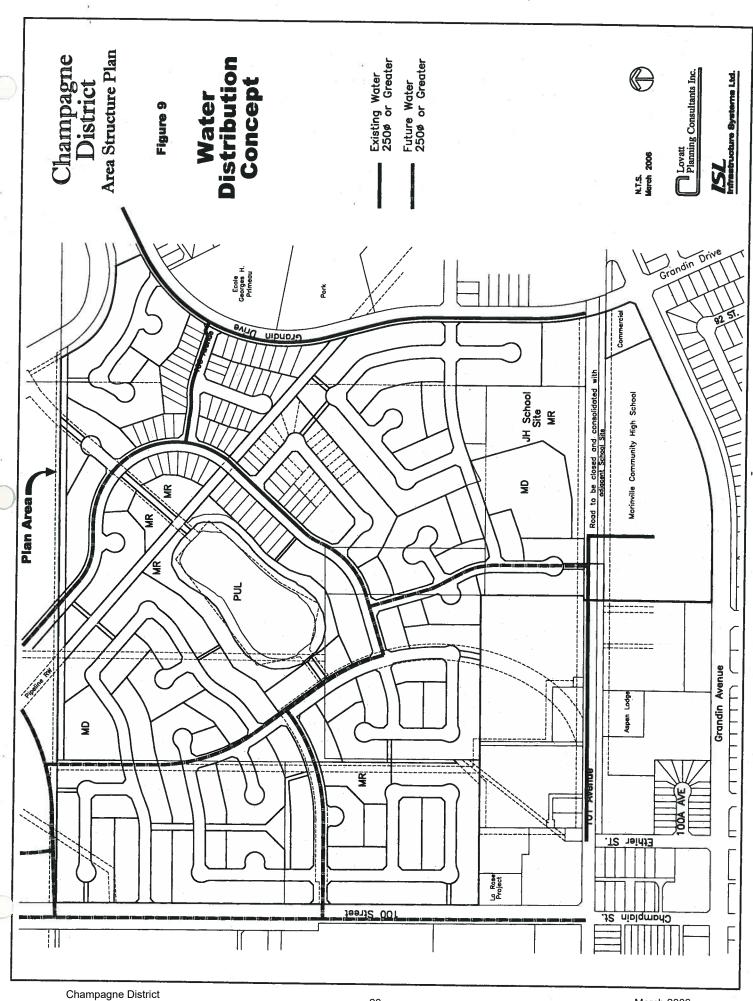
Water service to this Plan will be provided by a looped system sized to provide acceptable domestic flows, with fire flows that achieve recognized standards for residential development (see Figure 9). Water supply is currently provided from a connection to Grandin Drive at 106th Avenue. As development approaches 80 lots, looping will be required by a connection to the existing 250mm main on 101st Avenue. Cost sharing will be required for any capacity in loop system that is required to service the parcel located directly west of the Plan.

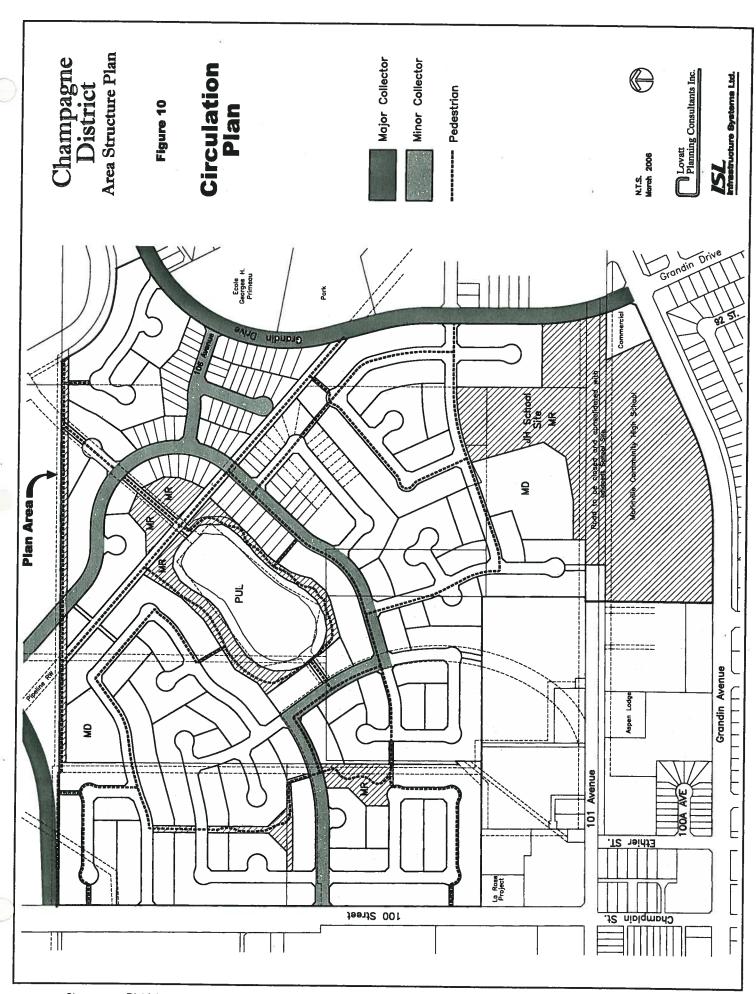
A pedestrian trail system will follow the Pembina pipeline right of way in the northeast quadrant of the area. Construction of this trail system will be dependent on the necessary permits from the oil company for construction within their right of way. This trail will link with a series of roads and public utility lots to form a comprehensive pedestrian network (see Figure 10).

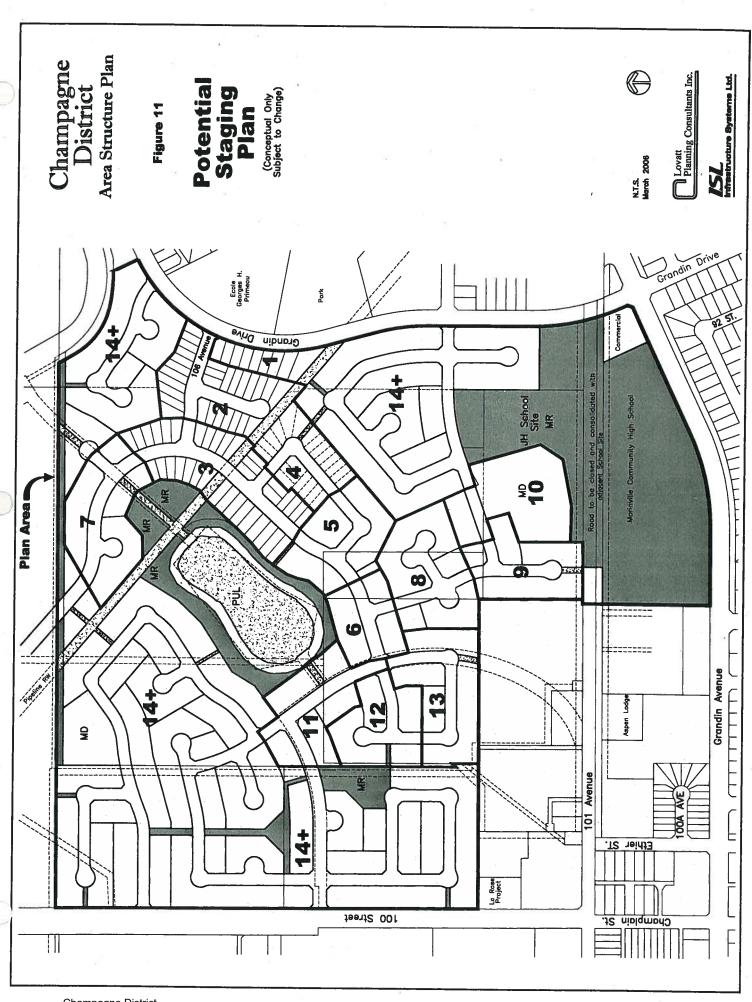
A Potential Staging Plan is shown on Figure 11. The first three phases are developed as Stages 1 to 3B. Stages 4 and 5 are imminent, and future stages are dependant on approval of this Area Structure Plan. Watermain looping and a temporary road will be required to allow the development of Stages 4 and 5.
